Final Report

Siler City Stormwater Infrastructure Mapping and Assessment Project

June 2020

Prepared by the
Triangle J Council of Governments
in partnership with
Biocenosis, LLC

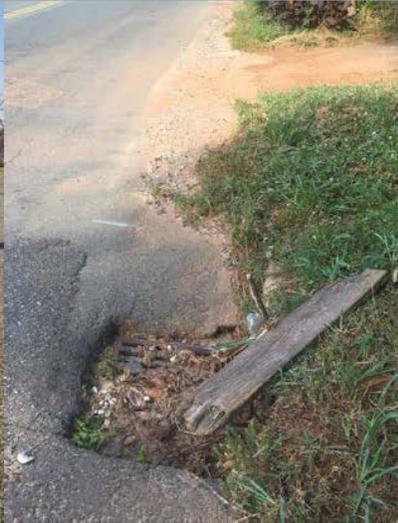
Clogged catch basin

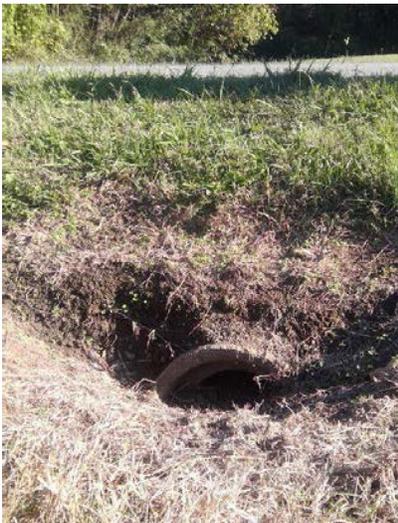
Mostly buried culvert

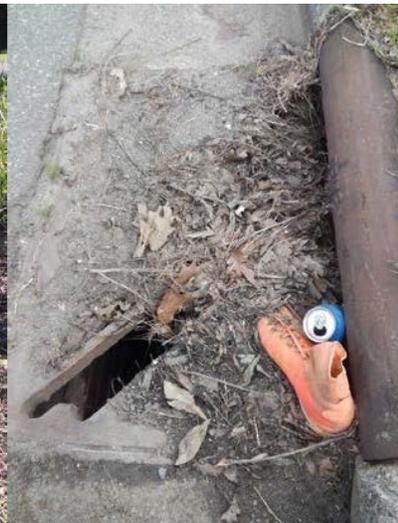
Clogged/broken catch basin

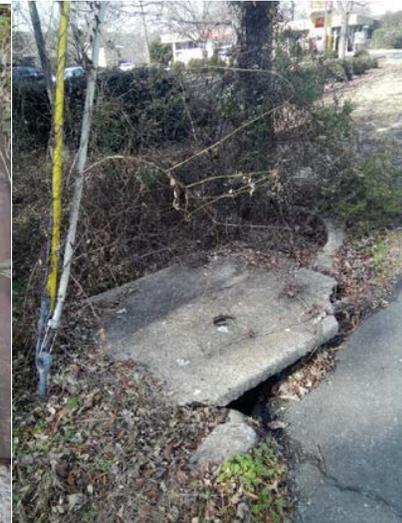
Broken (not clogged) curb inlet

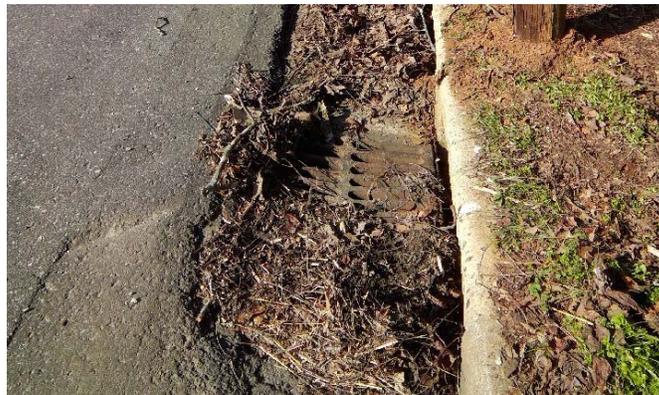
Figure 8: Catch Basin with Sediment, Leaves, Sticks

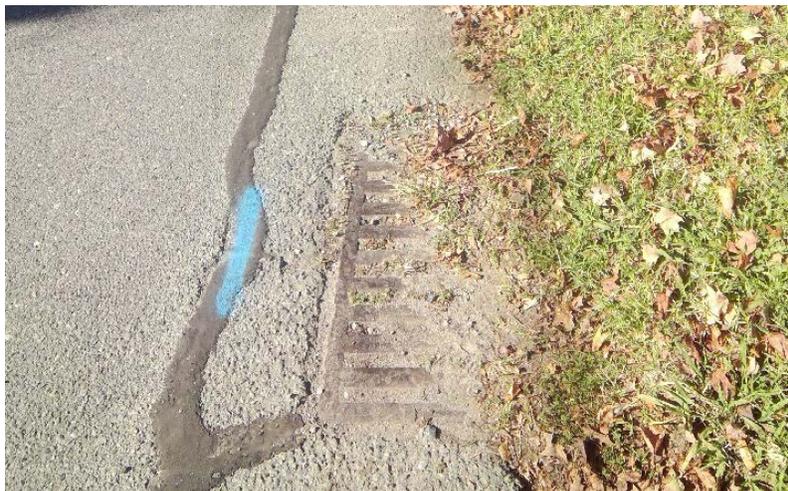
Figure 10: Catch Basin Full of Sediment (Cleaned 5/2020)

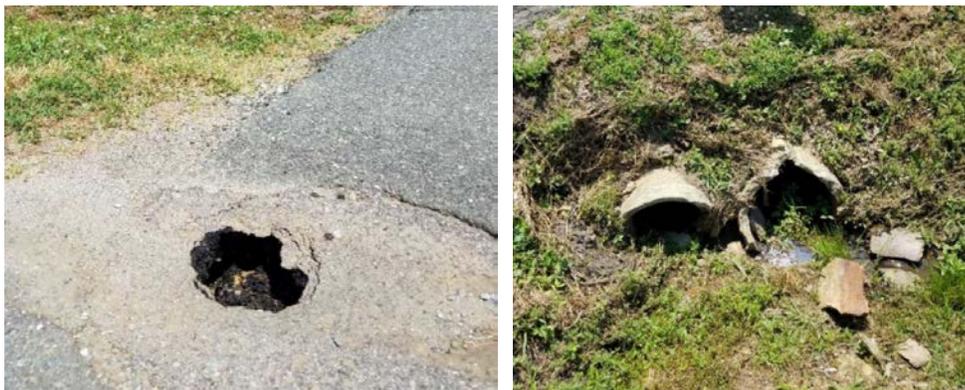
Figure 11: Sinkhole and Broken Pipes on West Second Street

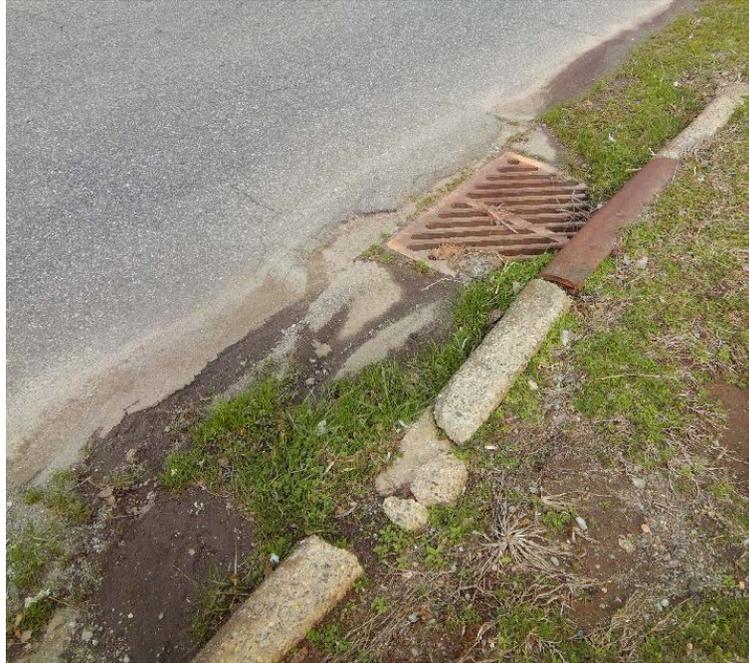
Figure 12: Erosion of Curb Next to Catch Basin on West Raleigh Street

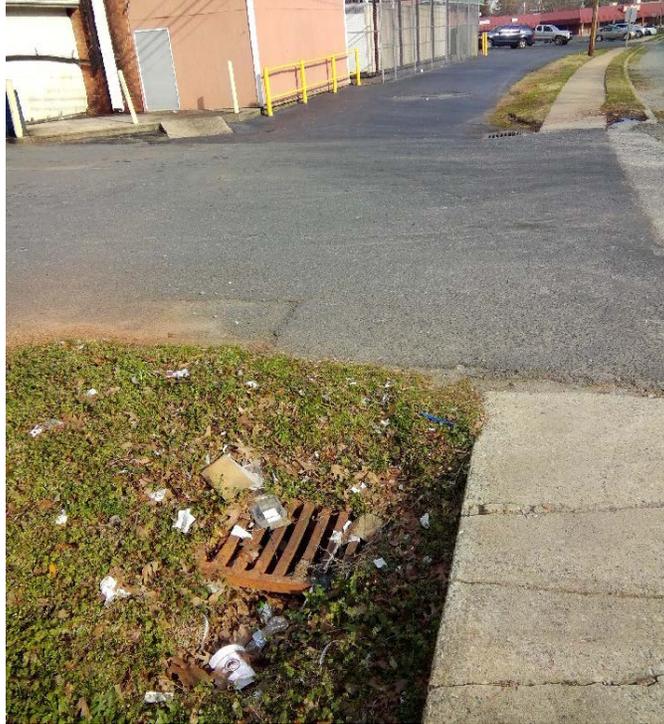
Figure 12 below shows how stormwater has picked up litter and dropped it a low-lying storm drain (here, outside the Piggly Wiggly on West Raleigh St.) after which it will be washed into the creek.

Figure 13: Litter in Catch Basin Outside Piggly Wiggly

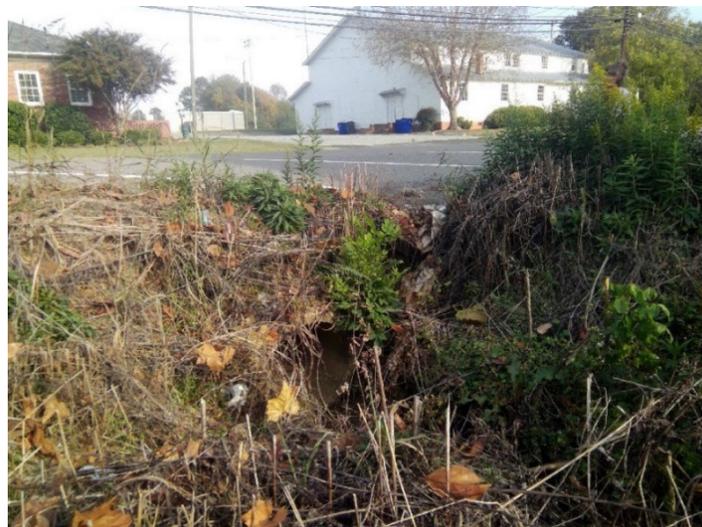
Figure 14: Clogged/Broken Outfall Pipe and Litter on Third Ave.

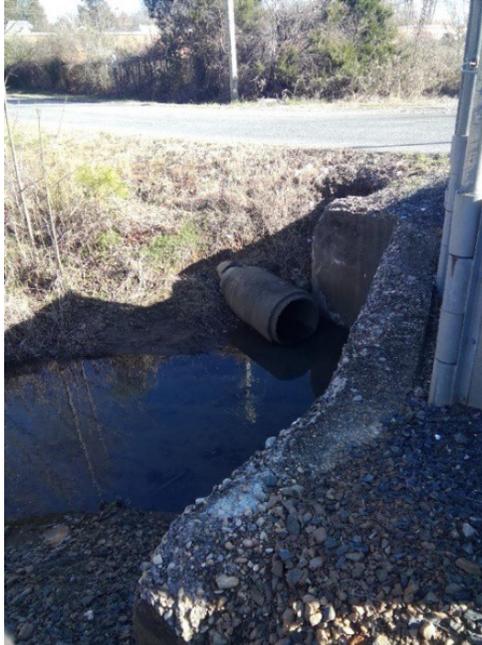
Figure 16: Outfall Pipe with Oil Sheen

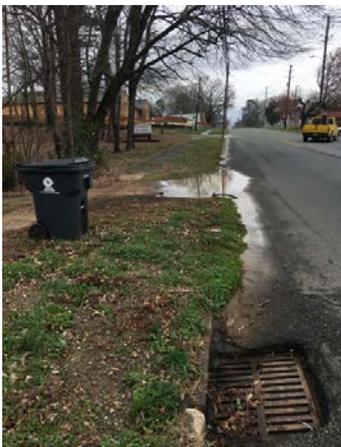
The section of West Third Street between Garden Avenue and North Fir Avenue carries a lot of stormwater runoff overwhelming the State’s stormwater infrastructure. Clogged and broken stormwater infrastructure doesn’t appear to be the problem. On April 22, 2020, a NC DOT Engineer sketched the stormwater drains as shown in map below and noted that “All inlets and pipes are working well, and none require maintenance at this time.” Rather than expanding stormwater infrastructure to move the stormwater downstream quicker and exacerbating downstream flooding, a SCM such as a bioretention cell could be installed. Potential sites for SCMs located on private property that would capture runoff before it enters the stormwater drains can be seen in the map below.

Stormwater runoff on W. Third Street

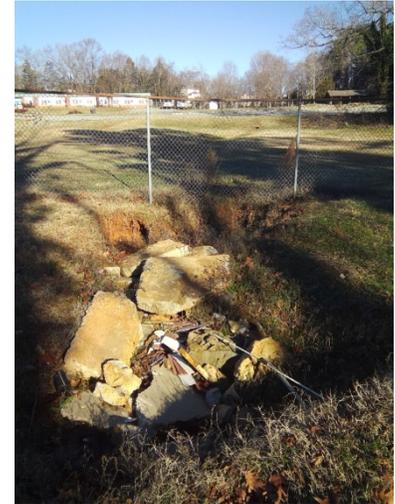
A stormwater collection system east of the Paul Braxton Ball Field on Town property directs stormwater to the stormwater pipe that flows under Chestnut Street. The outflow system is broken and eroding. Potentially a SCM such as a Regenerative Stormwater Conveyance system could be installed to slow and reduce the flow.

Stormwater outflow to system from ball field.

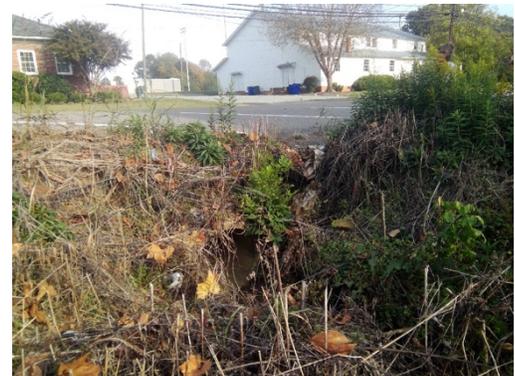
Outfall from stormwater pipe under Third Ave into ditch

Rain gardens could be installed on town property to reduce stormwater runoff to storm drains that empty into a ditch that ultimately joins Loves Creek.
