# Siler City Stormwater Infrastructure Lookbook: NCDOT-Owned Streets

*Highest-Priority Stormwater Infrastructure Maintenance Needs*  
*Version date: June 2020*

# Completed as Part of the Siler City Stormwater Mapping and Assessment Project

Prepared by the  
Triangle J Council of Governments  
in partnership with  
Biocenosis, LLC

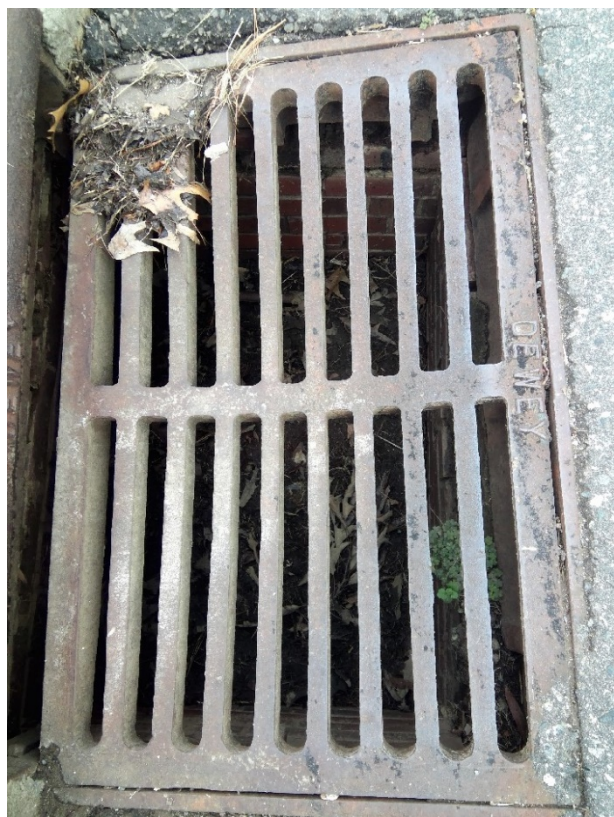
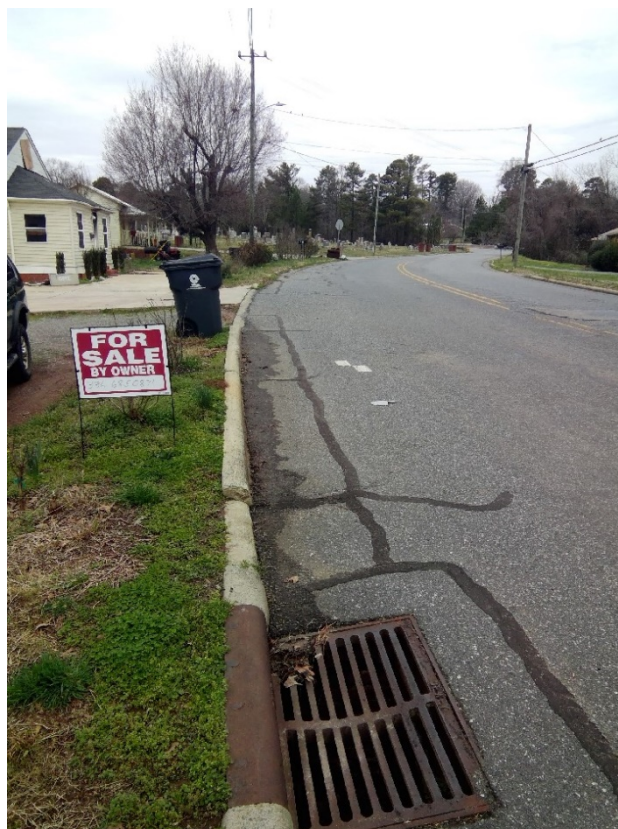
**Structure ID:** D5ST\_CB01

**Observed condition:** Needs Improvement

**Cleanout needed:** YES

**Cleanout description:** Almost Completely full of sediment

**Pollutant description:** Sediment

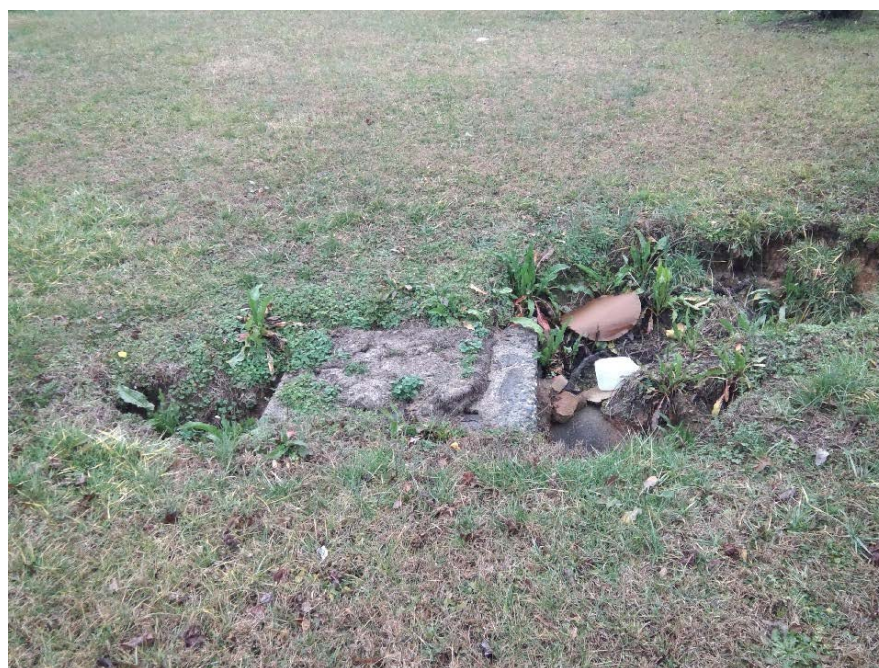
**Structure ID:** D6ST\_CB01

**Observed condition:** Needs Improvement

**Condition description:** Erosion/sinkhole around clogged grate, can't see in

**Cleanout needed:** YES

**Pollutant description:** Litter, grass clippings

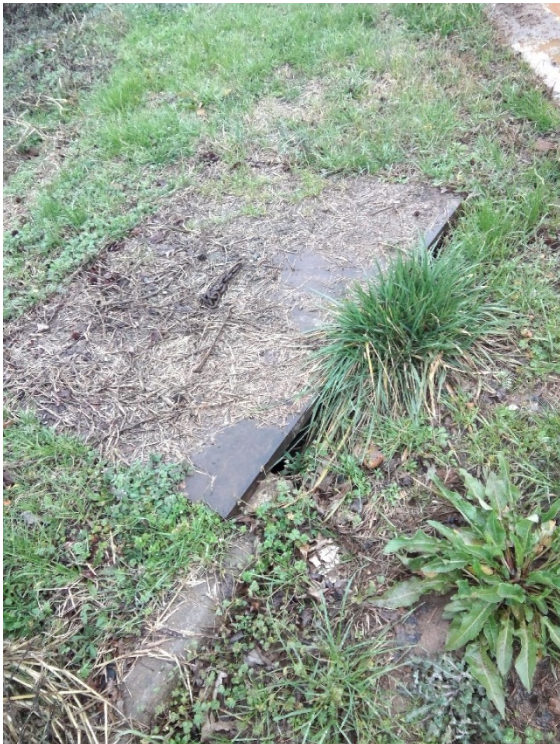
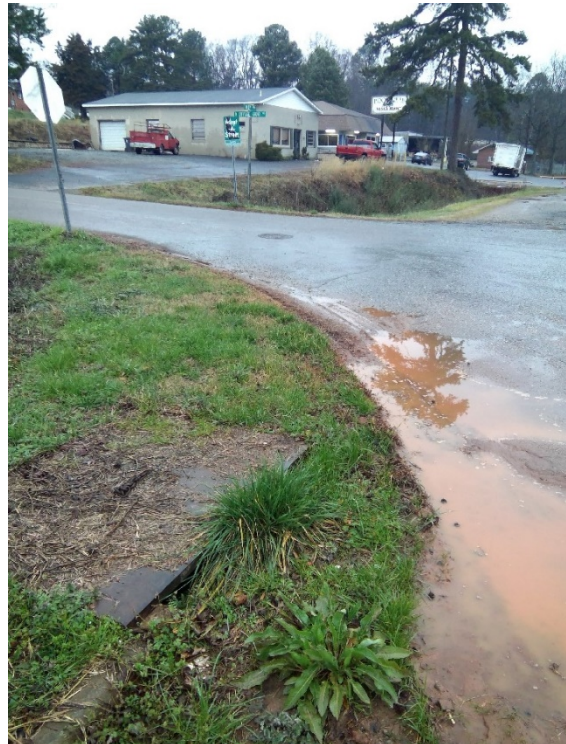
**Structure ID:** D6ST\_CB06

**Observed condition:** Needs Improvement

**Cleanout needed:** YES

**Observed pollution:** YES

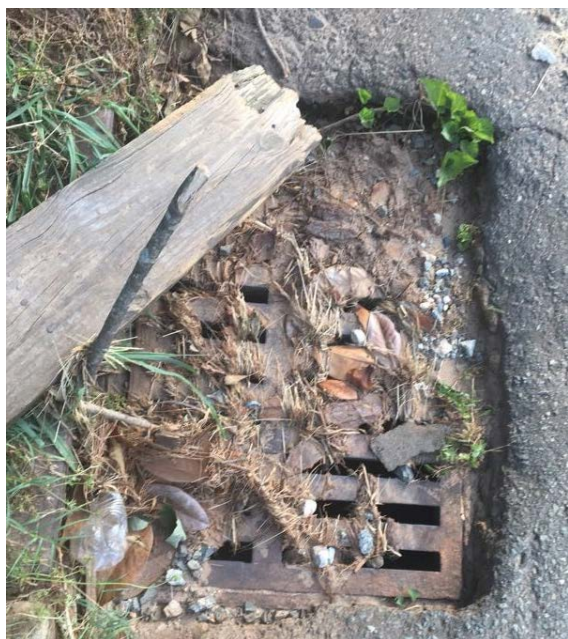
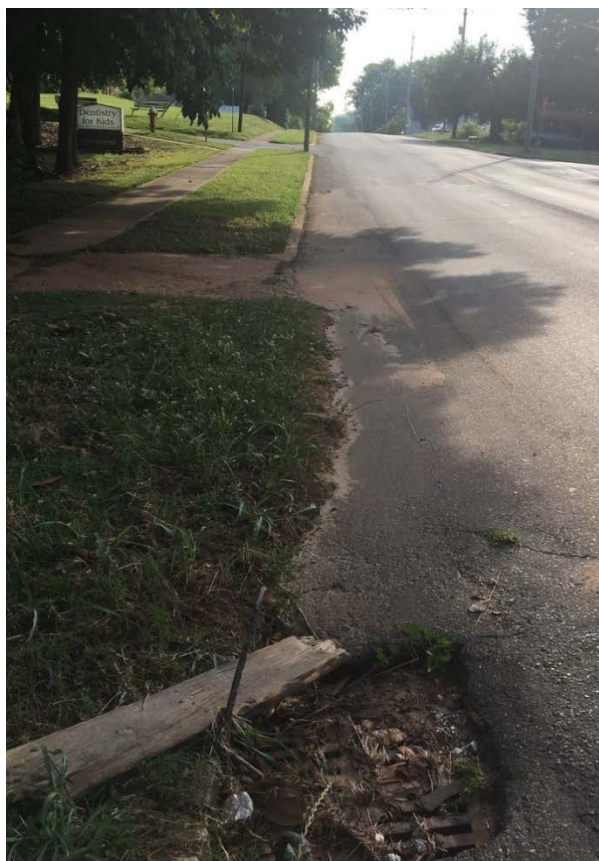
**Structure ID:** G5ST\_CB02

**Observed condition:** Needs Improvement

**Condition description:** Concrete crumbling on edge

**Cleanout description:** Debris fills most of grate, sediment on sidewalk

**Pollutant description:** litter, sediment, branches, leaves

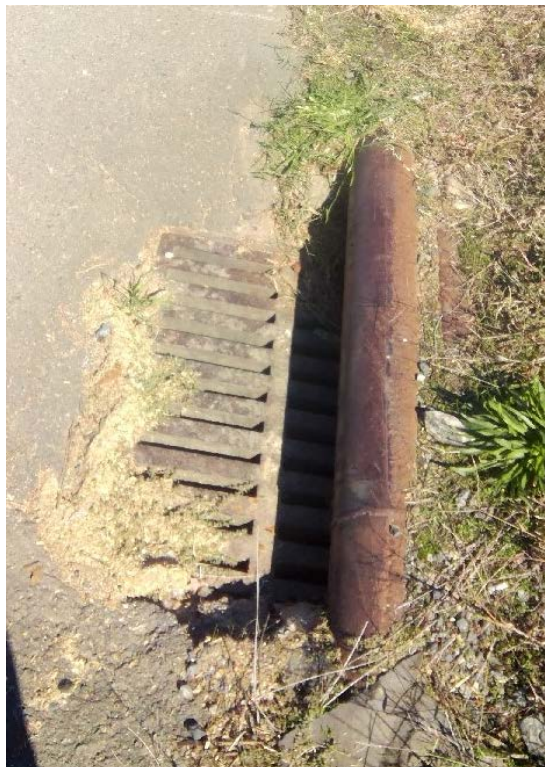
**Structure ID:** G6ST\_CB05

**Observed condition:** Needs Improvement

**Cleanout description:** Clogged with wood chips/animal bedding. Can't see inflow, clogged with animal bedding, possible inflow from across street?

**Pollutant description:** organic debris

**Other comments:** This outfalls via pipe on private property into boggy ditch by railroad

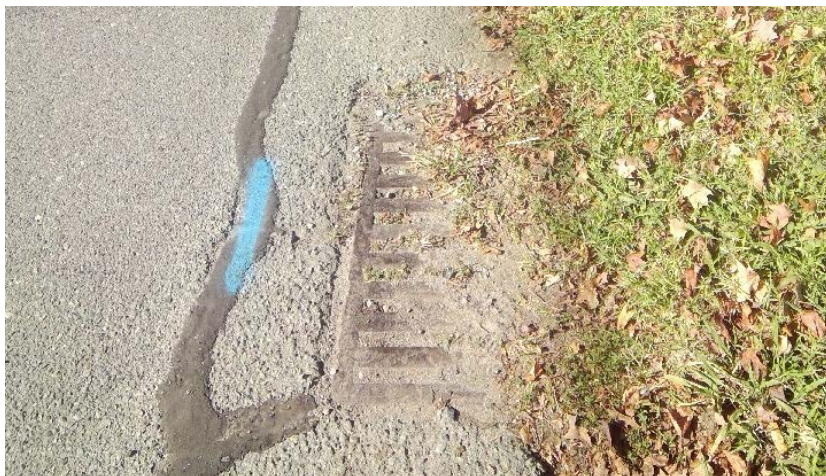
**Structure ID:** G6ST\_CB07

**Observed condition:** Needs Improvement

**Condition description:** Completely blocked

**Cleanout description:** completely full of sediment

**Other comments:** Cleaned by Siler City staff 5/2020

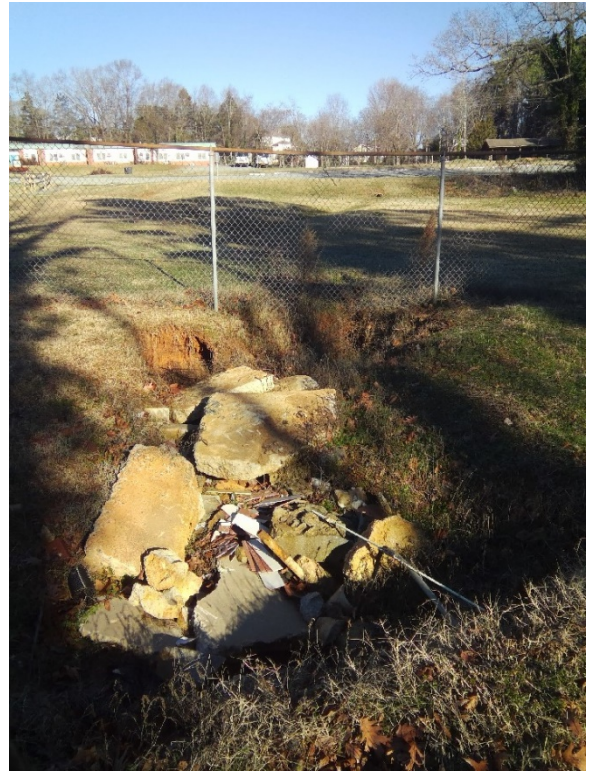
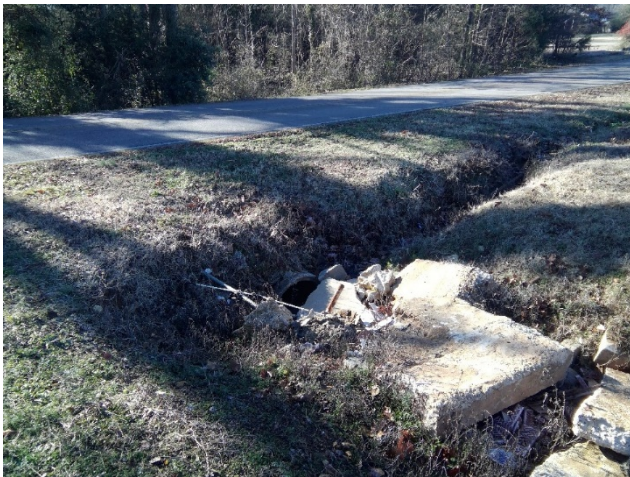
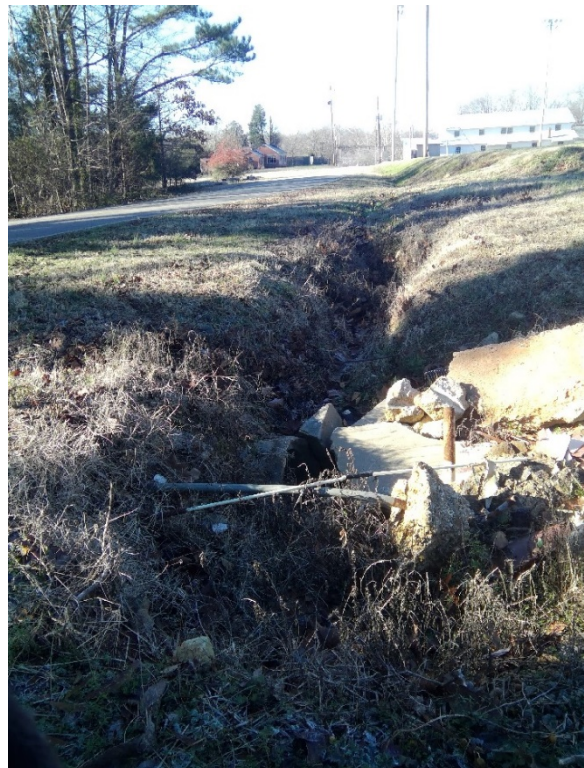
**Structure ID:** G9ST\_CV02

**Observed condition:** Needs Improvement

**Cleanout description:** Outfall to creek clogged w leaves. Multiple small pipes from private property deposit water to culvert; massive erosion someone is trying to stabilize w chunks of concrete

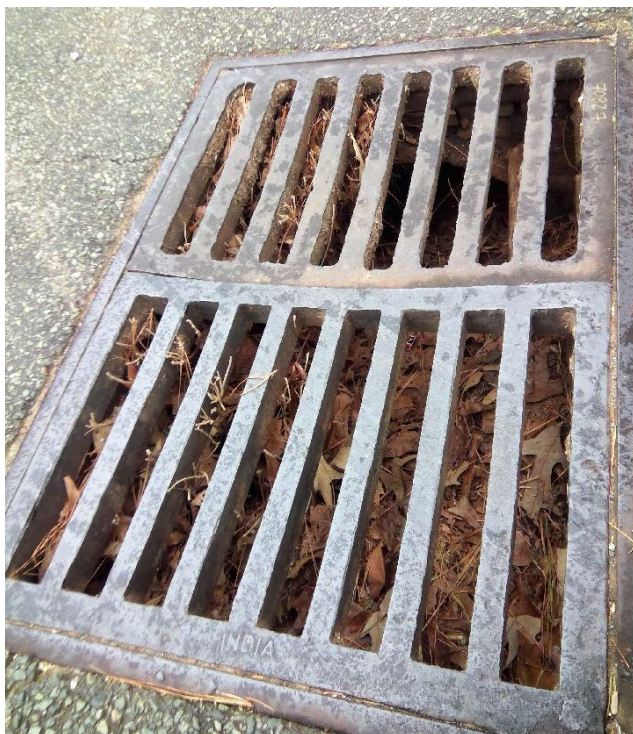
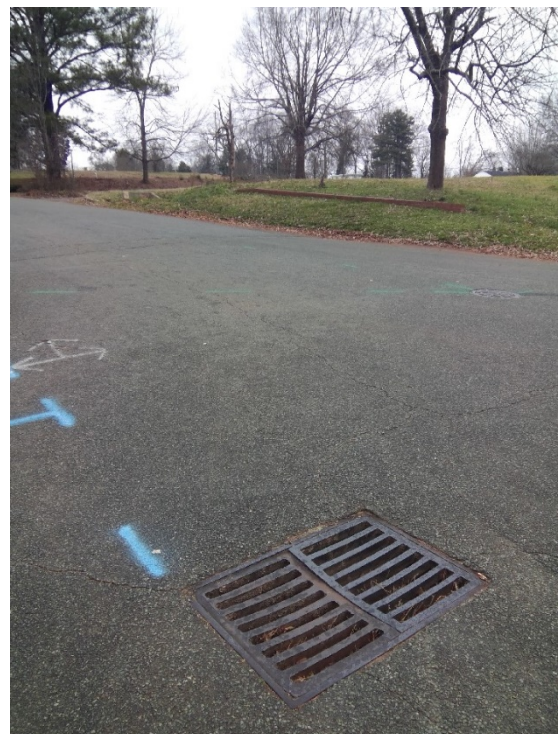
**Structure ID:** H4ST\_CB02

**Observed condition:** Needs Improvement

**Cleanout needed:** YES

**Observed pollution:** YES

**Other comments:** Probably gets runoff from old hospital site

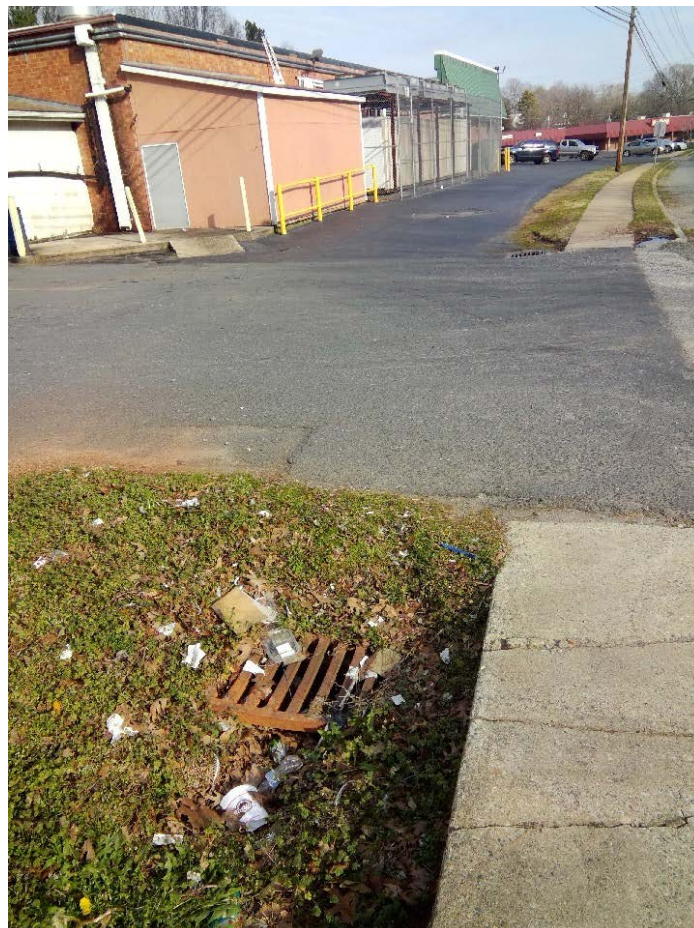
**Structure ID:** H5ST\_CB01

**Observed condition:** Needs Improvement

**Cleanout description:** Full of trash/buried

**Observed pollution:** YES

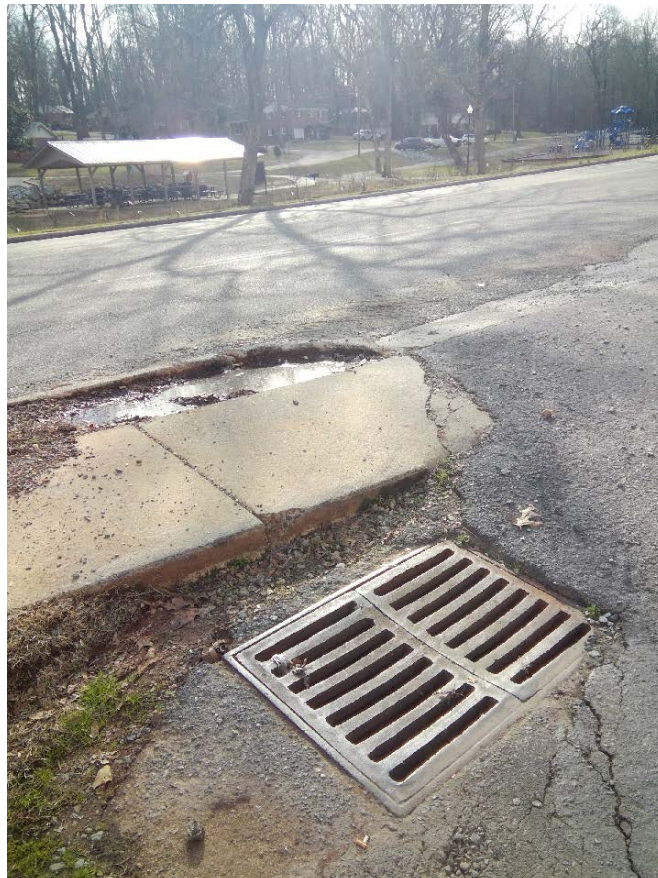
**Structure ID:** H5ST\_CB02

**Observed condition:** Needs Improvement

**Cleanout description:** Large chunks of asphalt inside

**Observed pollution:** YES

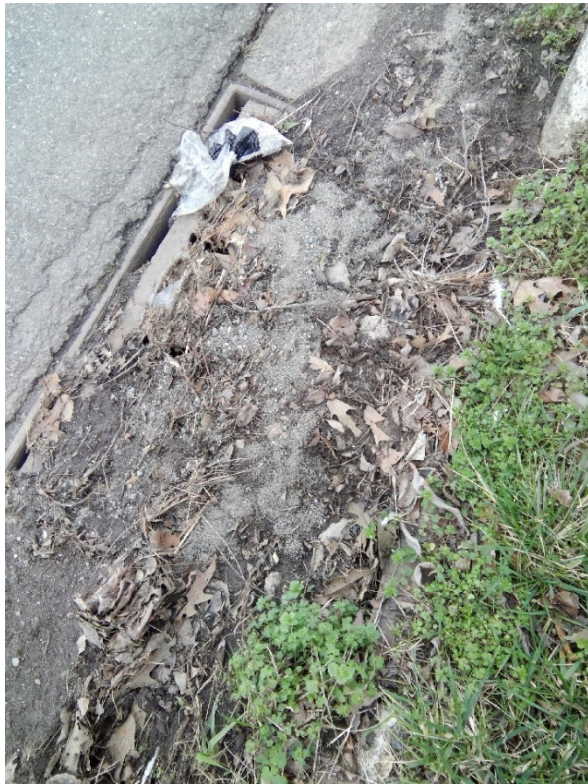
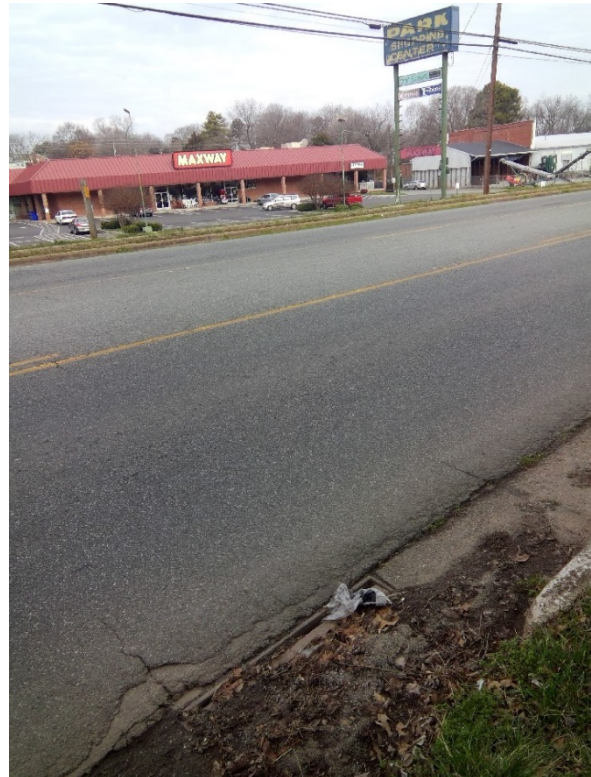
**Structure ID:** H5ST\_CB05

**Observed condition:** Needs Improvement

**Cleanout needed:** YES

**Observed pollution:** YES

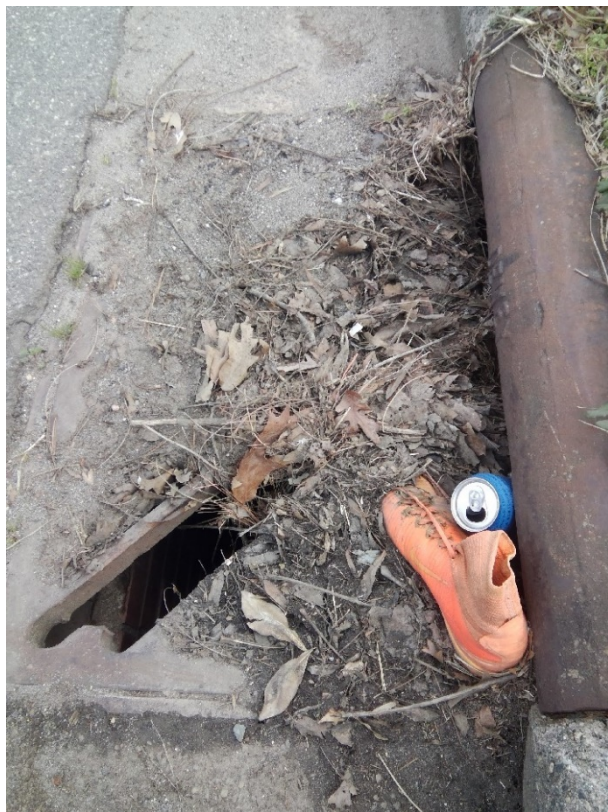
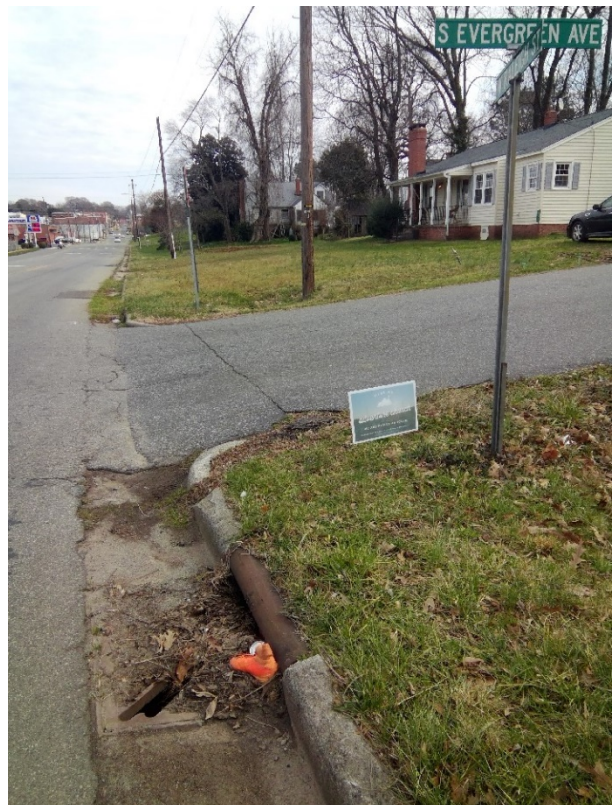
**Structure ID:** H5ST\_CB06

**Observed condition:** Needs Improvement

**Condition description:** At least one broken bar

**Cleanout needed:** YES

**Observed pollution:** YES

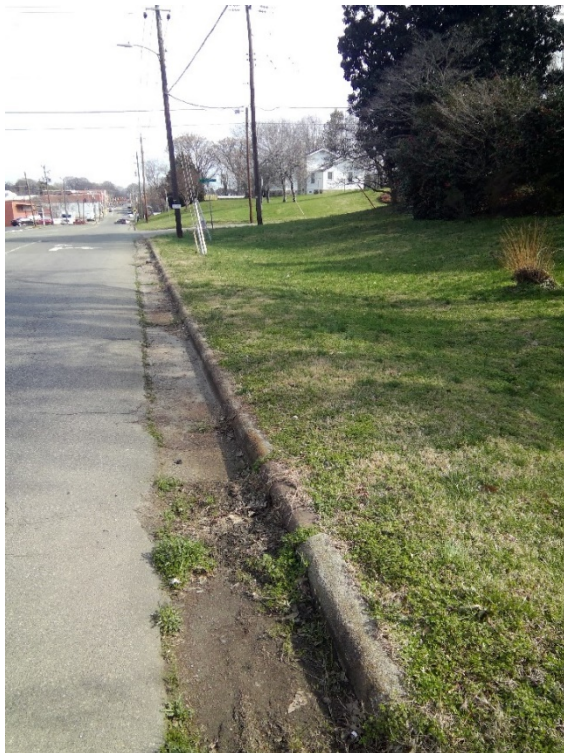
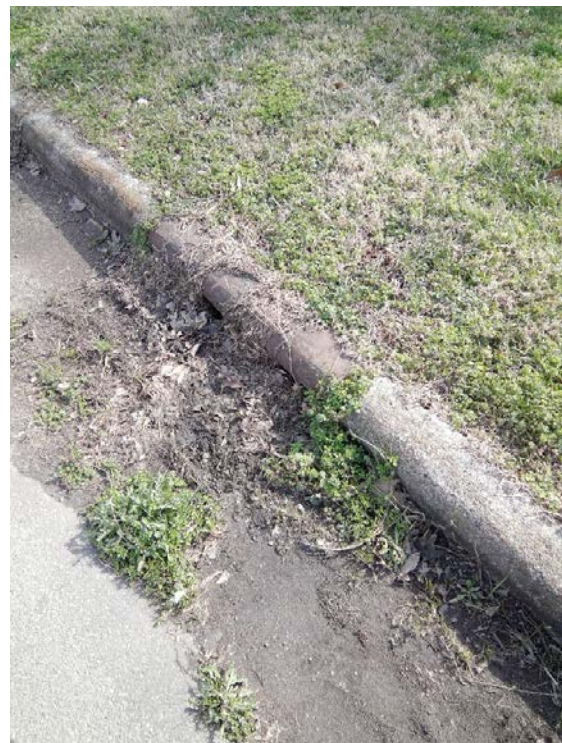
**Structure ID:** H7ST\_CB05

**Observed condition:** Needs Improvement

**Cleanout needed:** YES

**Cleanout description:** Fairly sure there's a catch basin under all this sediment- confirm

**Observed pollution:** YES

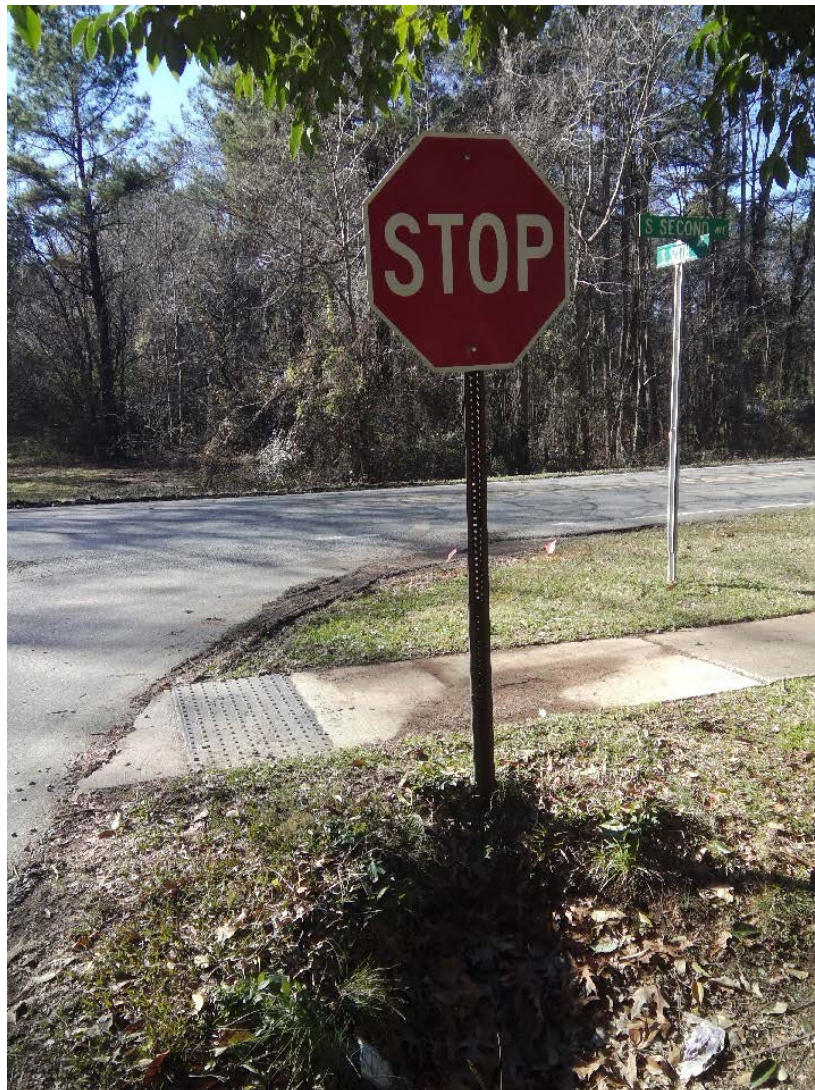
**Structure ID:** I9ST\_CV01

**Observed condition:** Needs Improvement

**Cleanout needed:** YES

**Cleanout description:** Fully buried, can't find one end

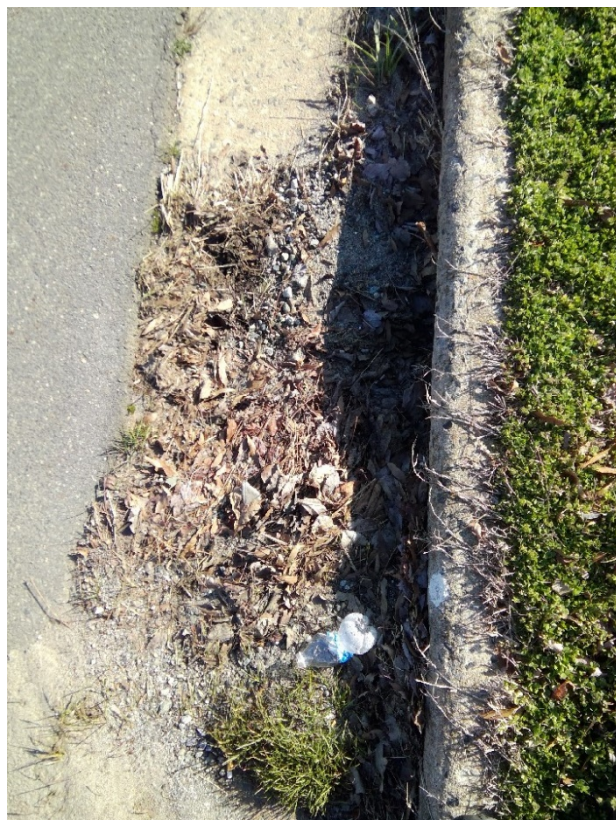
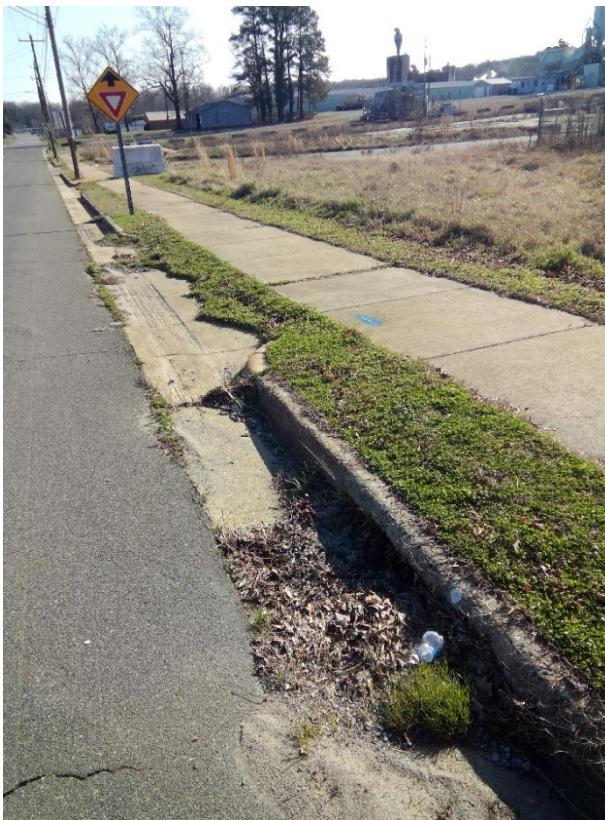
**Structure ID:** J8ST\_CB01

**Observed condition:** Needs Improvement

**Cleanout needed:** YES

**Observed pollution:** YES
