Siler City Stormwater Infrastructure Lookbook: Town-Owned Streets

Highest-Priority Stormwater Infrastructure Maintenance Needs
Version date: June 2020

Completed as Part of the Siler City Stormwater Mapping and Assessment Project

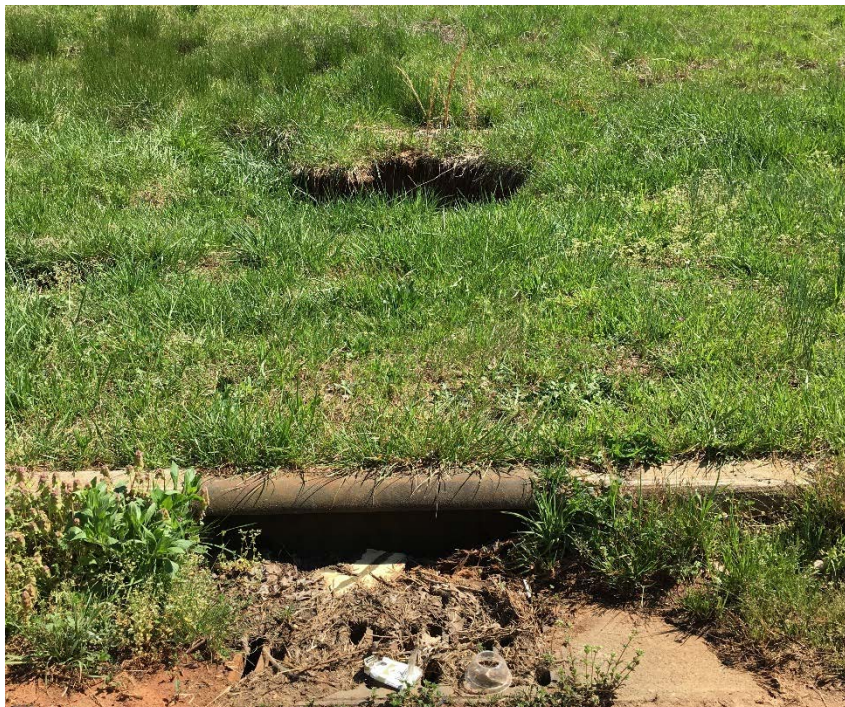
Structure ID: C2TN_CB03

Observed condition: Needs Improvement

Condition description: sinkhole forming behind

Cleanout description: Lots of plants growing in dirt around grate. Lots of debris/veg over grate

Pollutant description: sediment, organics

Other comments: Cleaned by Siler City staff 5/2020

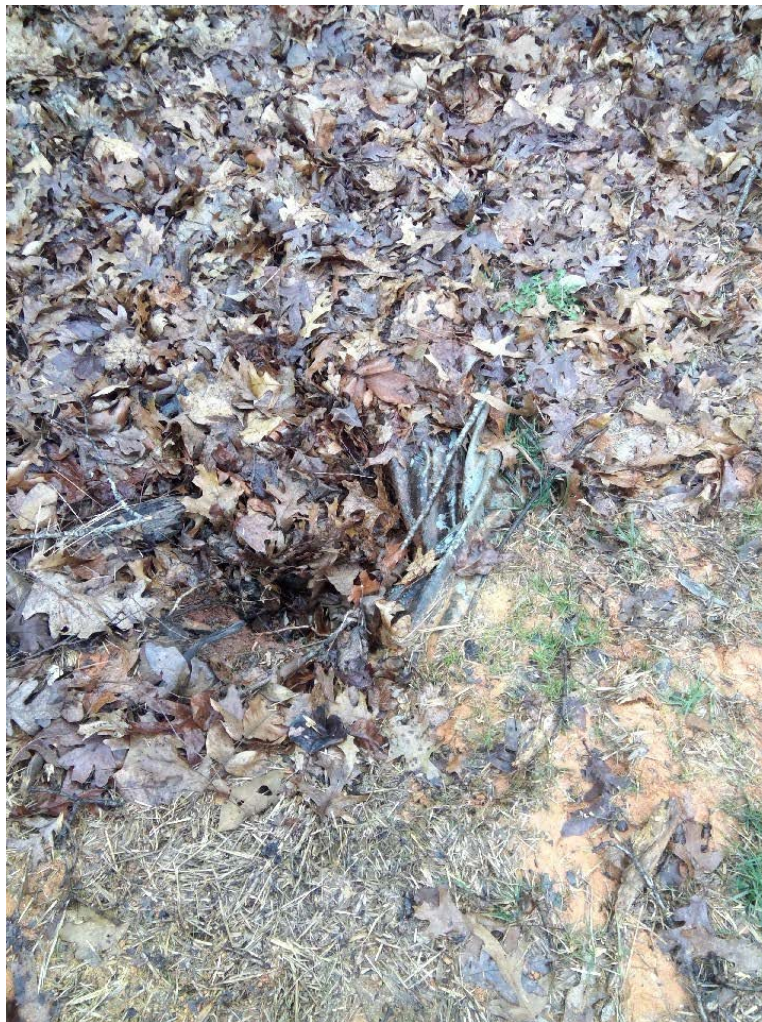
Structure ID: D1TN_CV01

Observed condition: Needs Improvement

Comments: Culvert appears nonfunctional

Cleanout description: May need replacement rather than cleanout

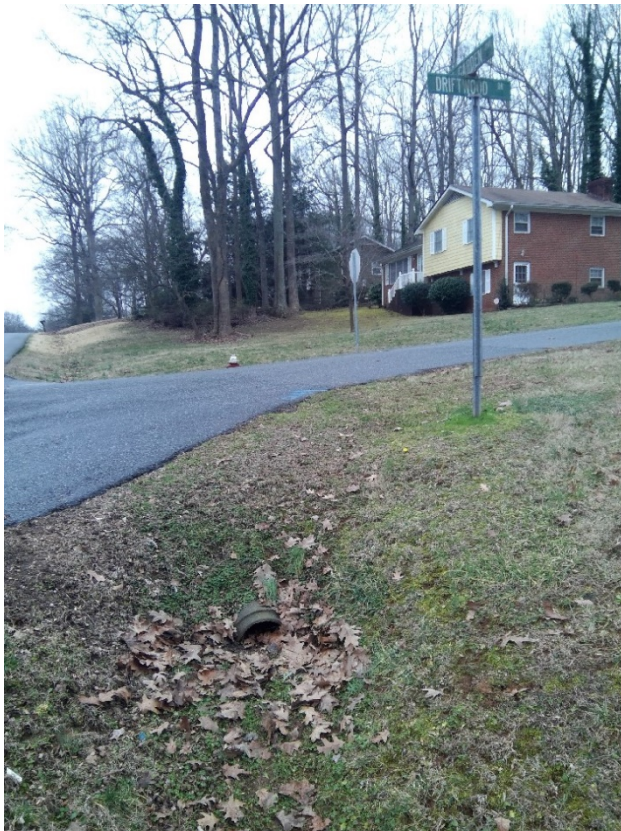
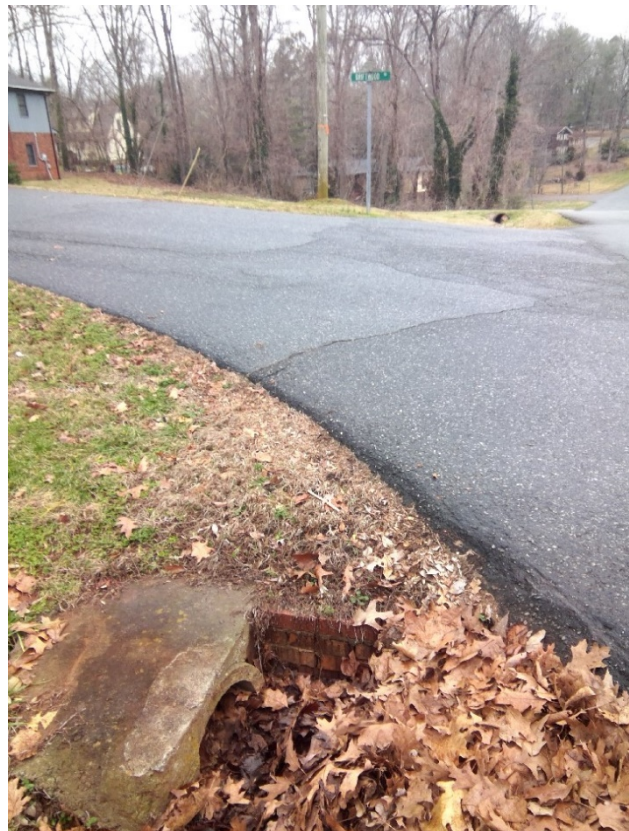
Structure ID: D3TN_CV01

Observed condition: Needs Improvement

Cleanout description: half buried

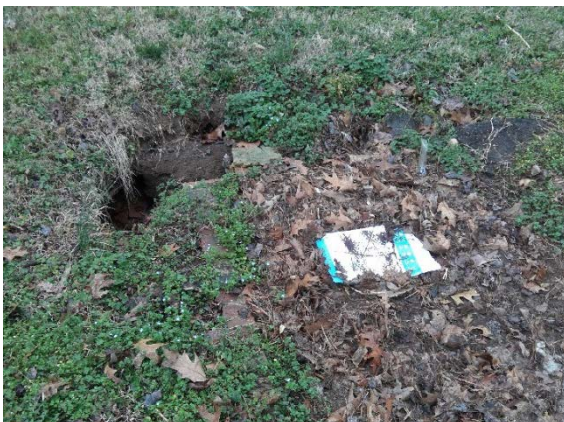
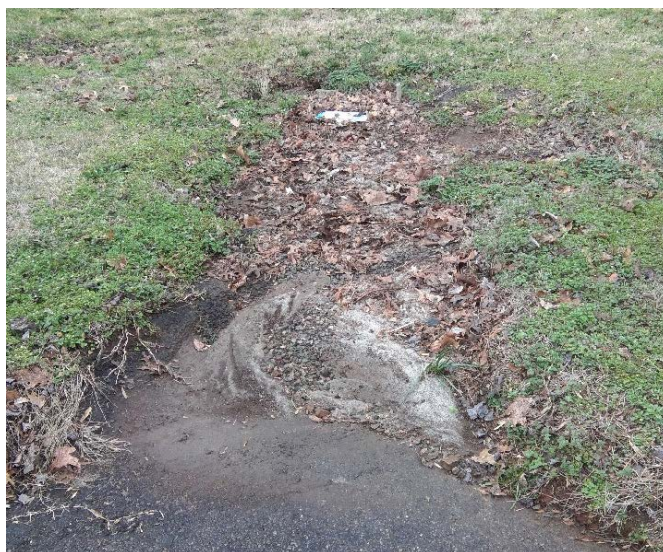
Structure ID: D3TN_CB03

Observed condition: Needs Improvement

Condition description: Sinkhole forming

Cleanout description: I think there's a CB under all the sand, silt, gravel

Pollutant description: Sand, silt

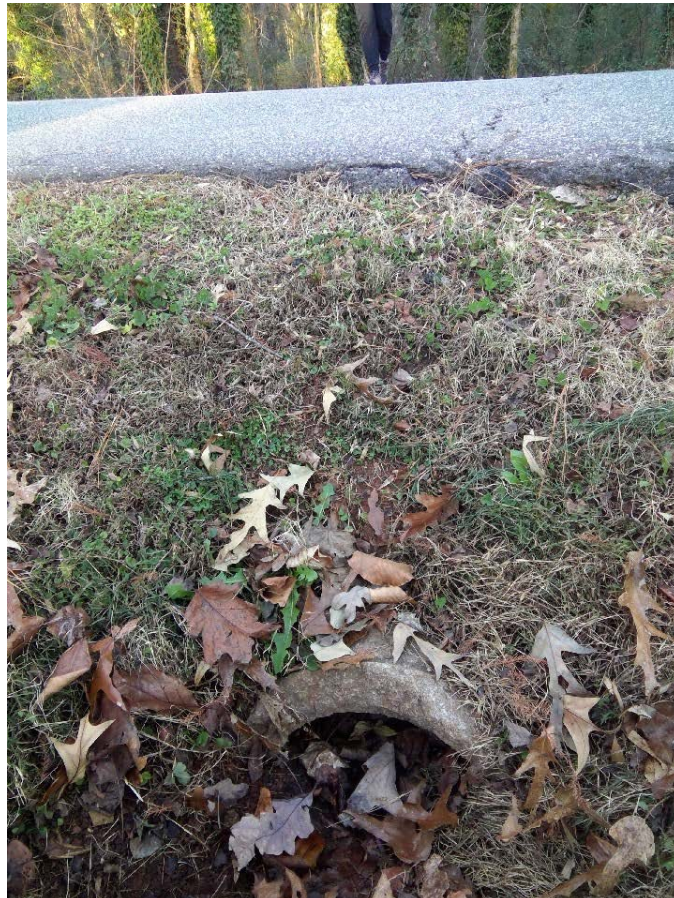
Structure ID: D4TN_CV03

Observed condition: Needs Improvement

Cleanout description: Mostly buried

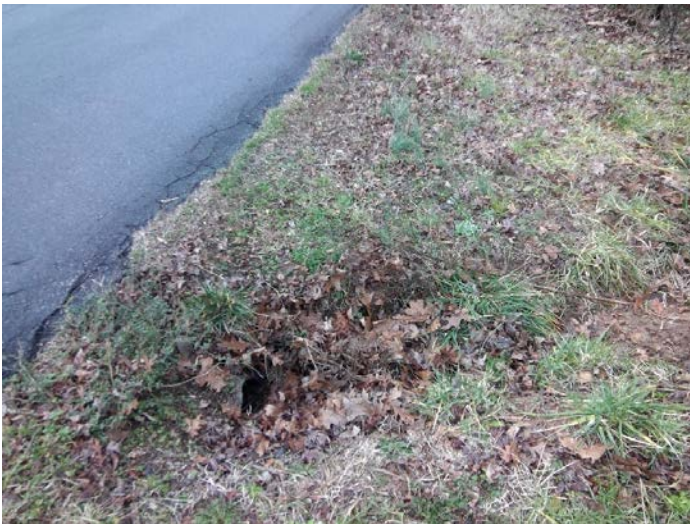
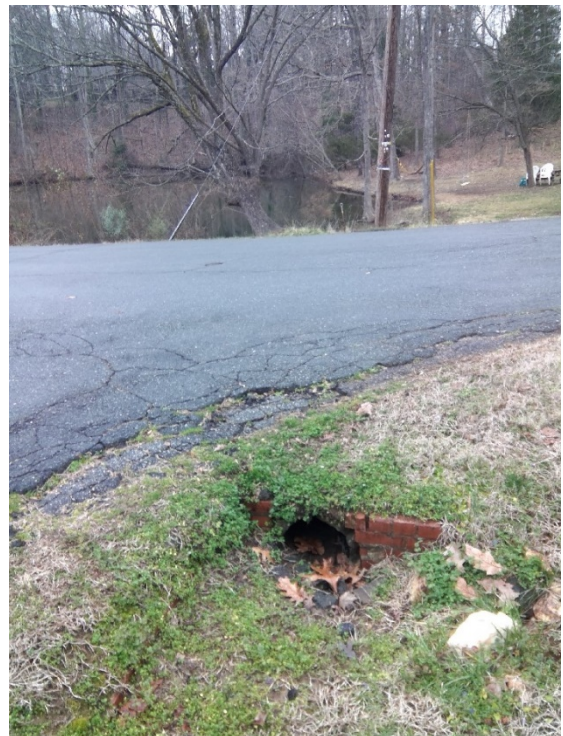
Structure ID: E2TN_CV01

Observed condition: Needs Improvement

Comments: Erosion from outflow to pond by base of telephone pole

Cleanout description: downslope partly buried

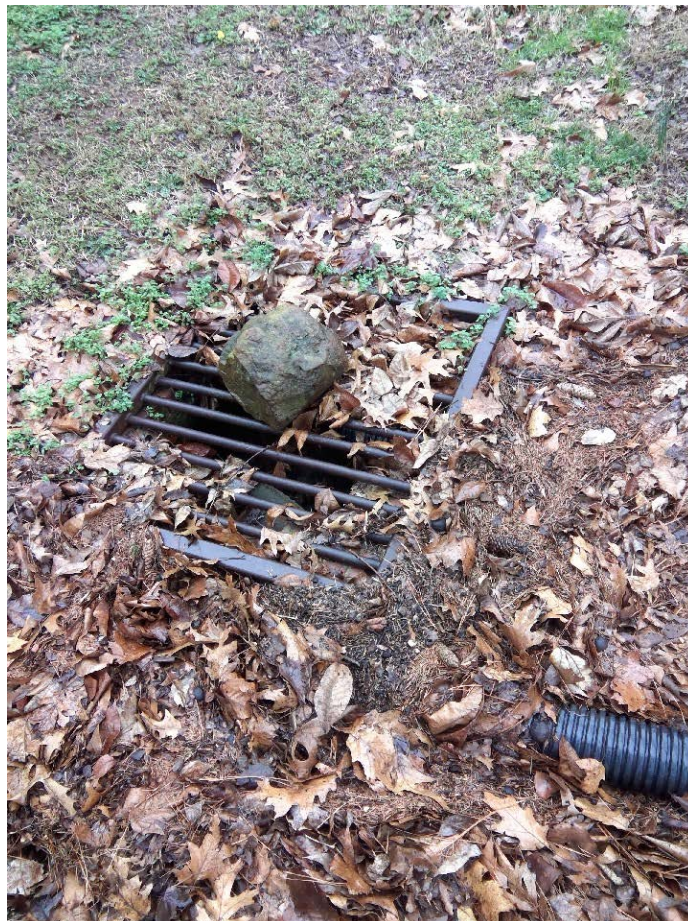
Structure ID: E3TN_CB02

Observed condition: Needs Improvement

Condition description: Grate secured by rock

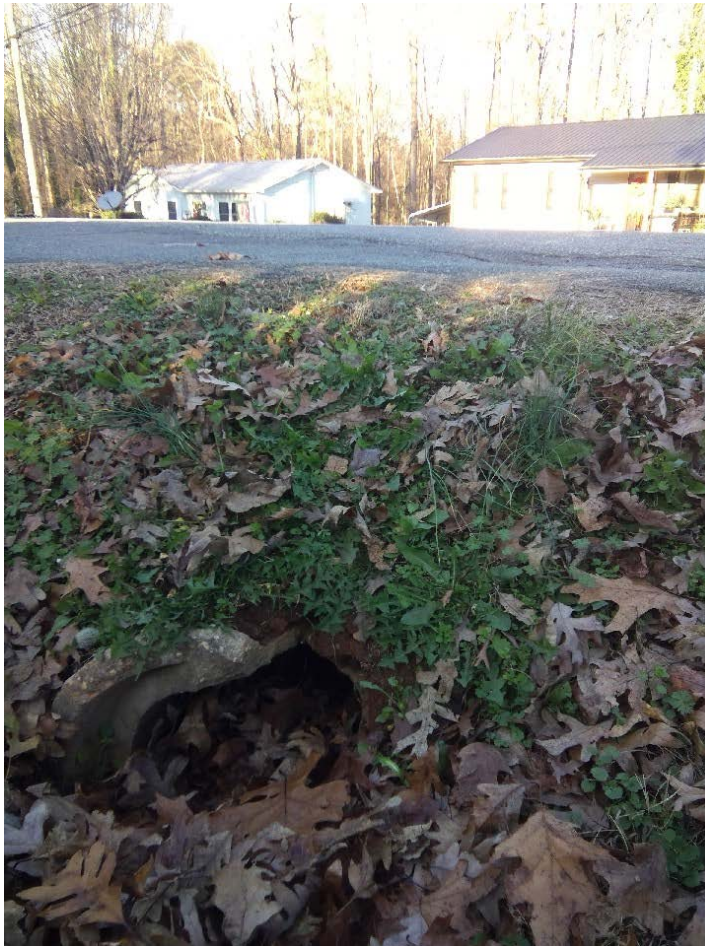
Structure ID: E5TN_CV02

Observed condition: Needs Improvement

Cleanout description: One end completely crushed causing road sink holes. Yard waste and sediment clogging pipe

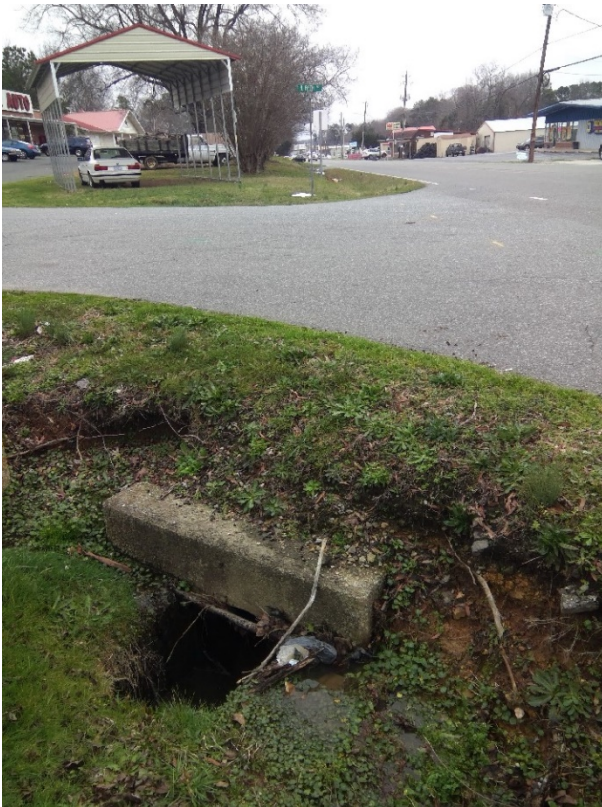
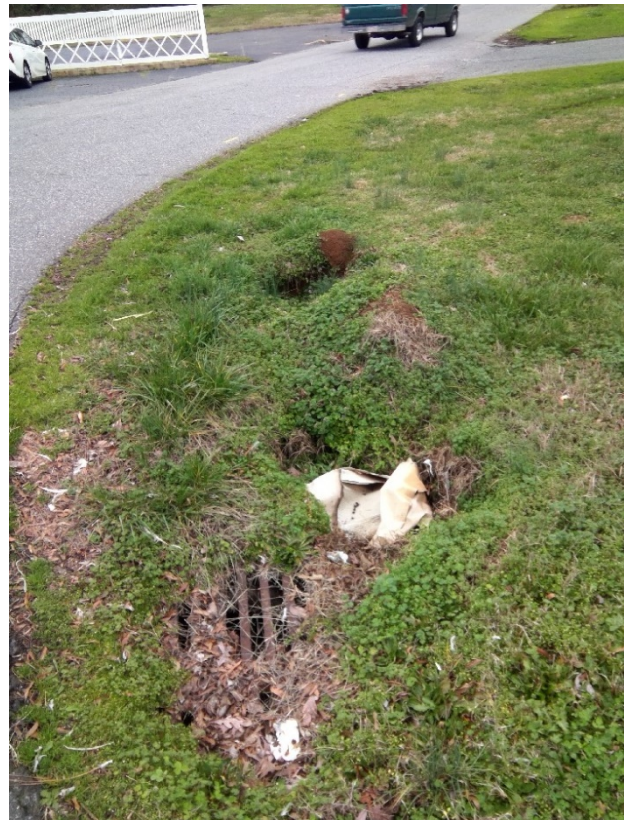
Structure ID: E8TN_CV01

Observed condition: Needs Improvement

Comments: If Connected to CB across N fifth ave, sinkholes around that CB

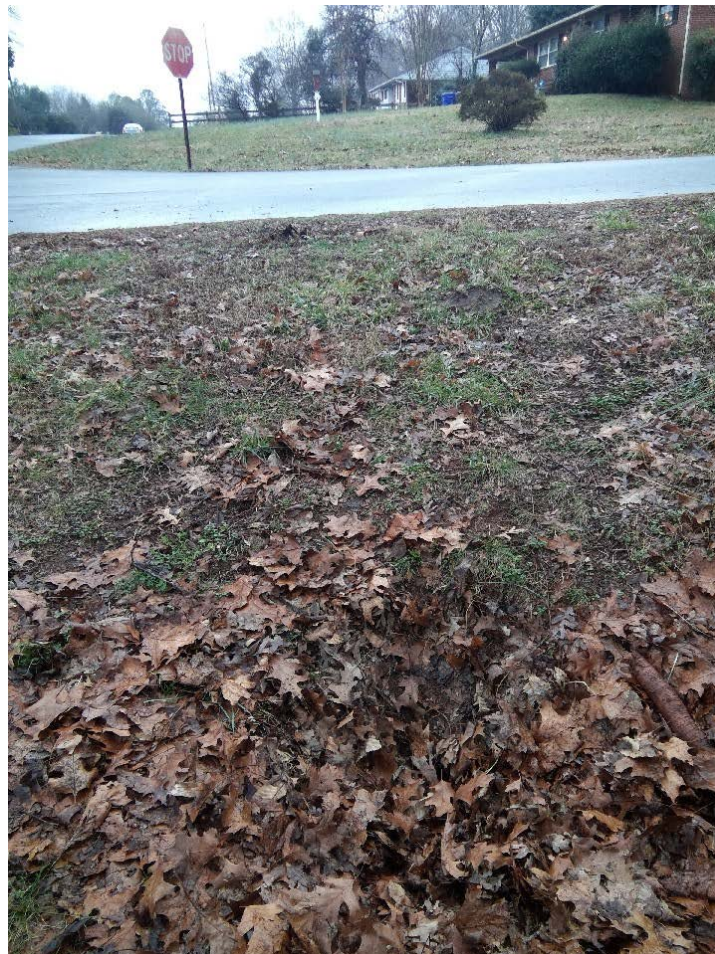
Structure ID: F2TN_CV01

Observed condition: Needs Improvement

Comments: Upslope from CB, downslope buried

Cleanout description: Downslope buried

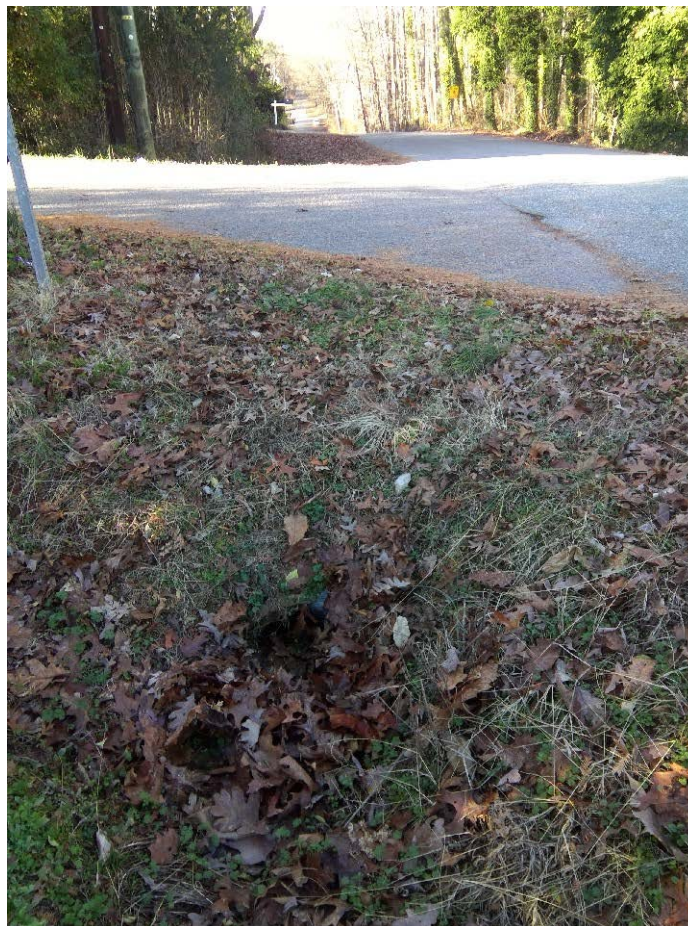
Structure ID: F4TN_CV03

Observed condition: Needs Improvement

Cleanout description: Mostly buried in sediment and leaves

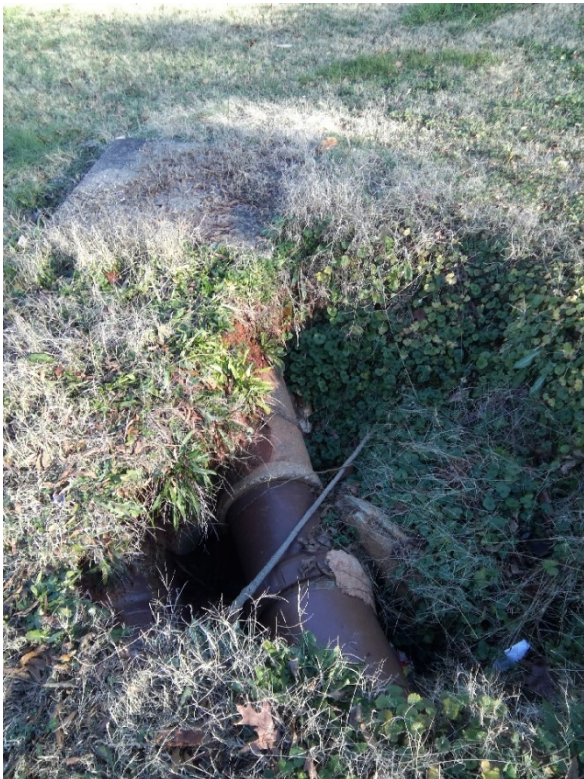
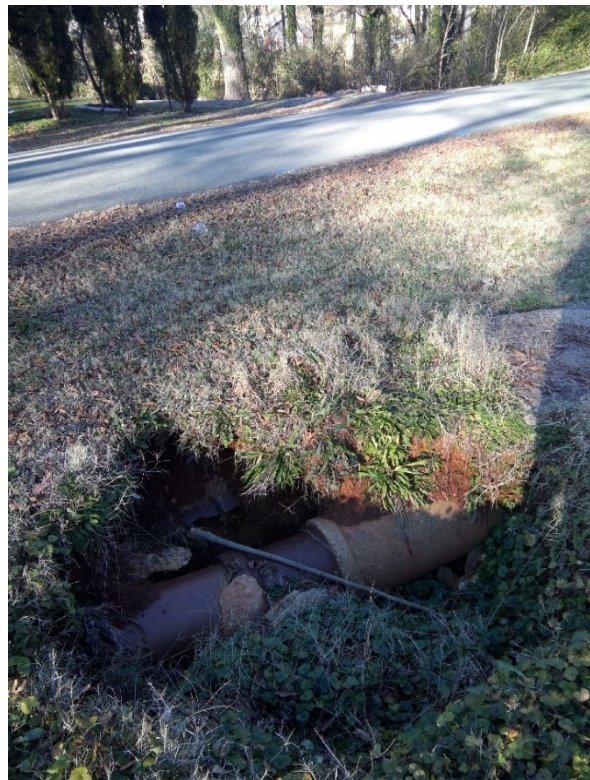
Structure ID: F5TN_SL01

Observed condition: Needs Improvement

Comments: Sinkhole. Leaking from join btwn terracotta and cement pipes' join. May be crushing terracotta pipe- unclear if still used

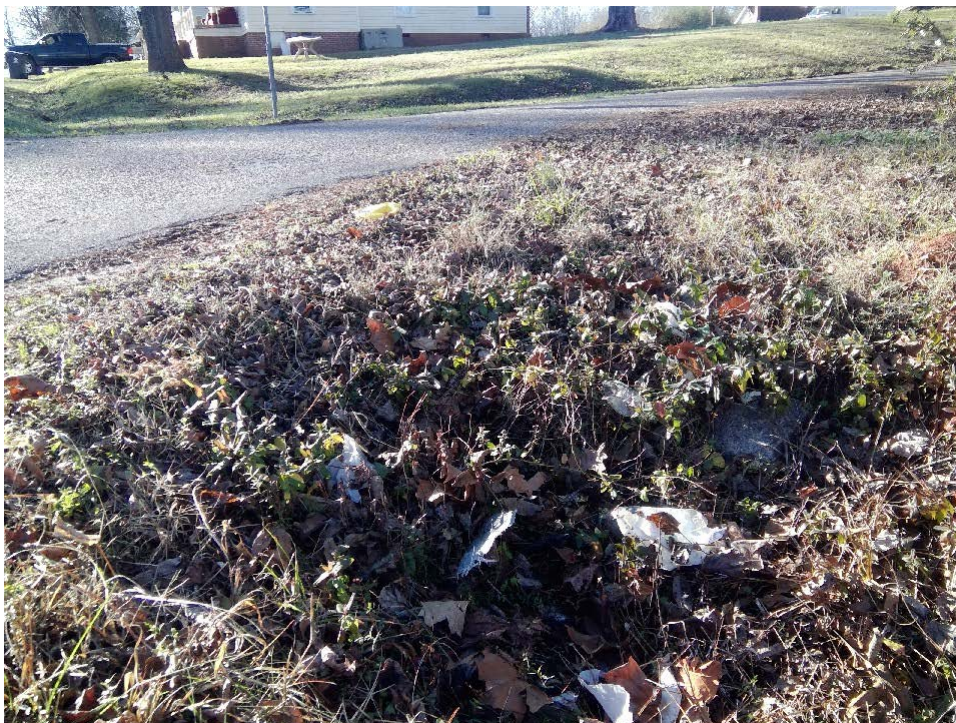
Structure ID: F6TN_CV03

Observed condition: Needs Improvement

Cleanout description: Buried

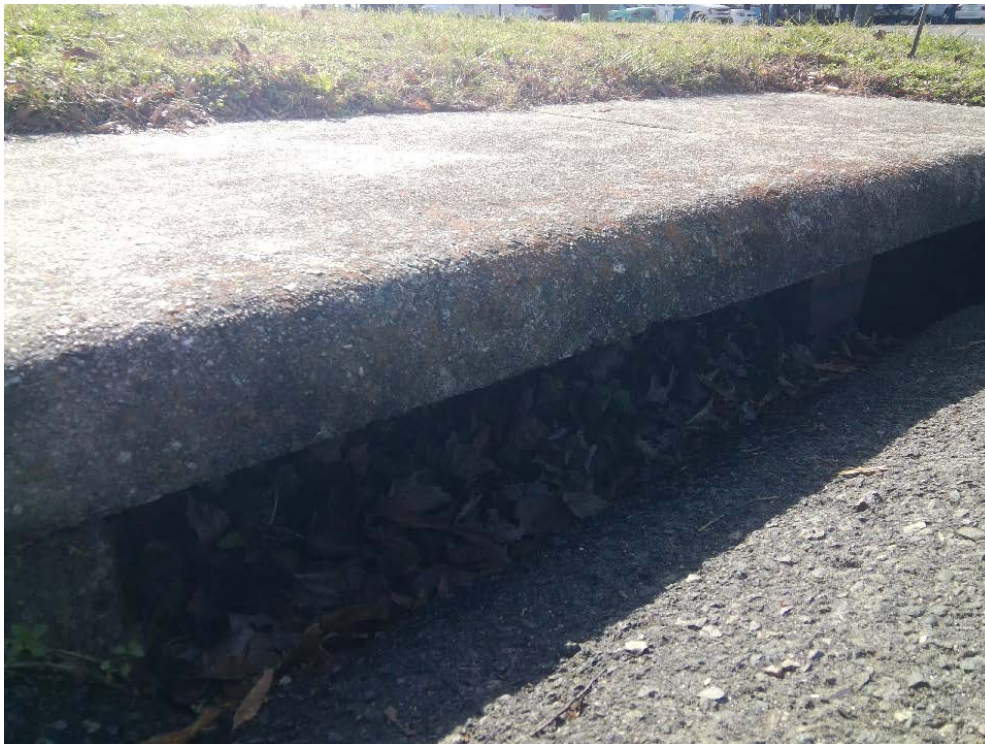
Structure ID: F7TN_CB02

Observed condition: Needs Improvement

Condition description: Full of leaves, can't see in

Cleanout description: Full of leaves

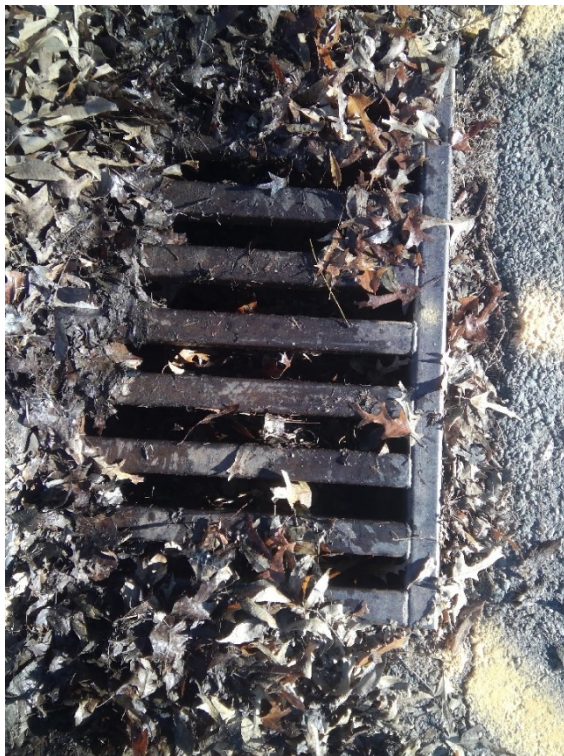
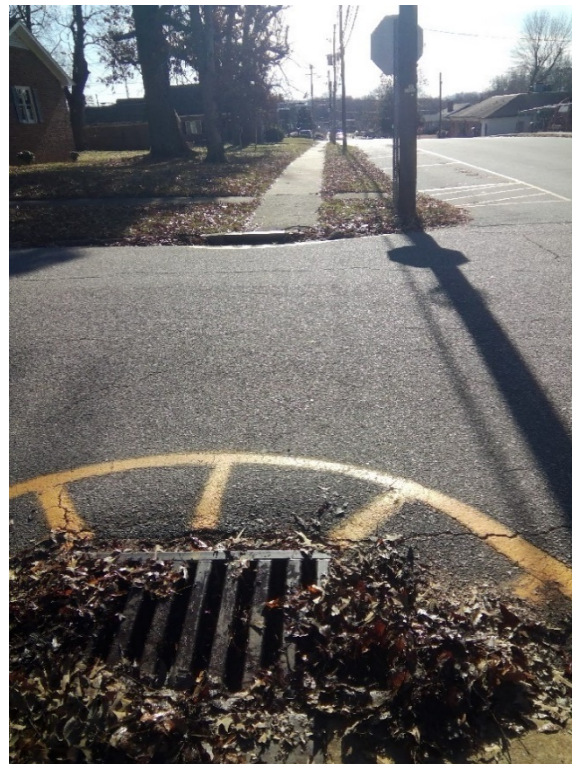
Structure ID: F8TN_CB02

Observed condition: Needs Improvement

Condition description: Completely full of leaves, can't see in

Cleanout description: completely full of leaves

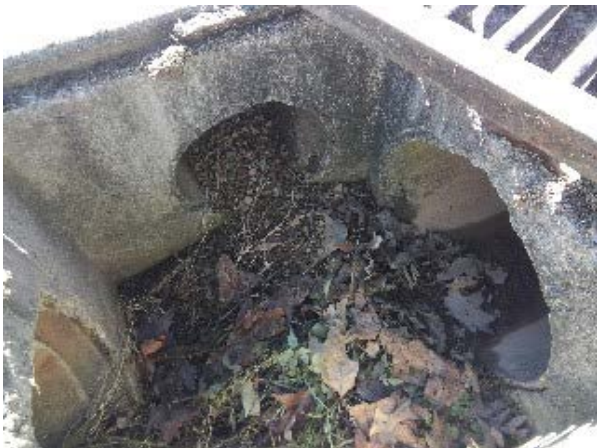
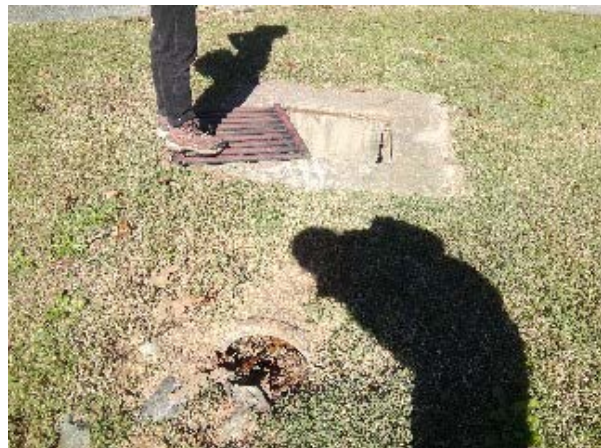
Structure ID: G3TN_CB01

Observed condition: Needs Improvement

Condition description: Found grate off, clogged with stuff

Cleanout description: Sediment, leaves, plants in bottom

Pollutant description: Sediment and organic debris

Separate pipe flowing to CB from outside

Other comments: Cleaned by Siler City staff 5/2020

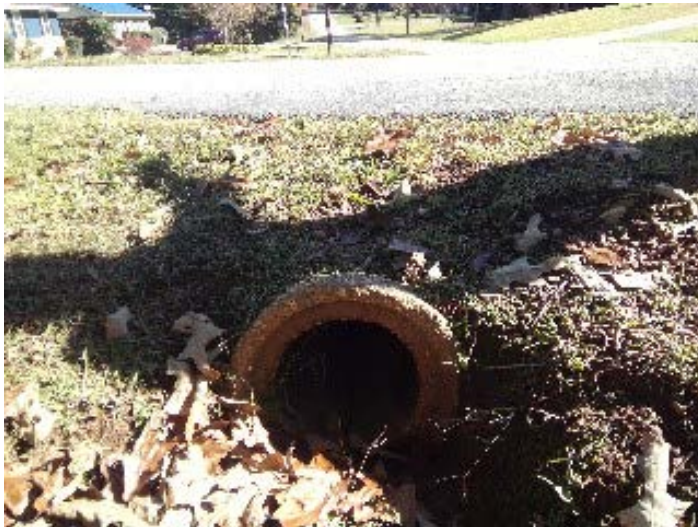
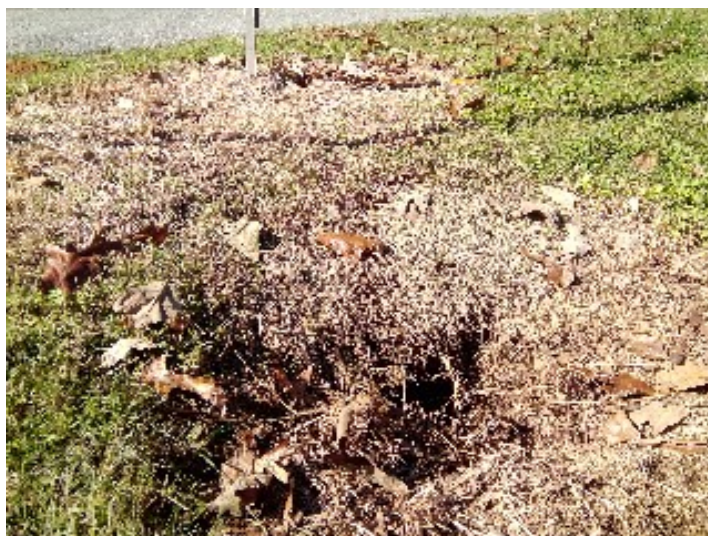
Structure ID: G3TN_CV01

Observed condition: Needs Improvement

Cleanout description: Outflow side totally clogged w grass, litter, sediment. Also a sinkhole above outflow

Comments: Cleaned by Siler City staff 5/2020

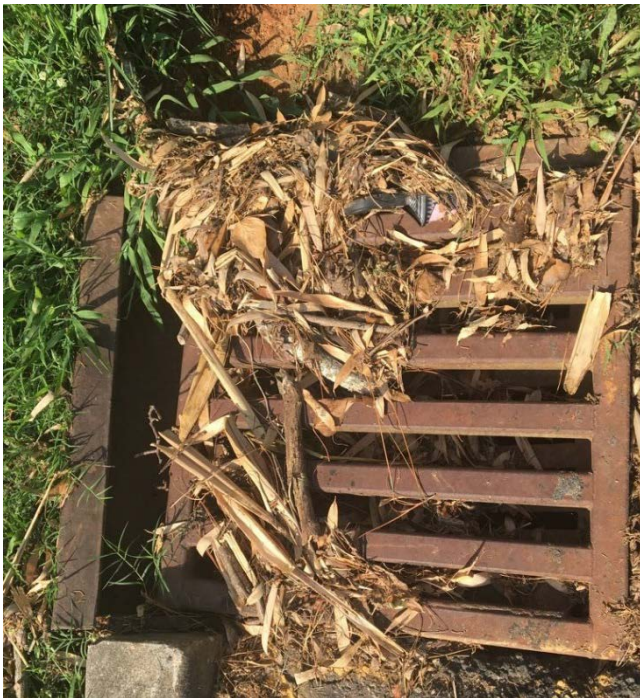
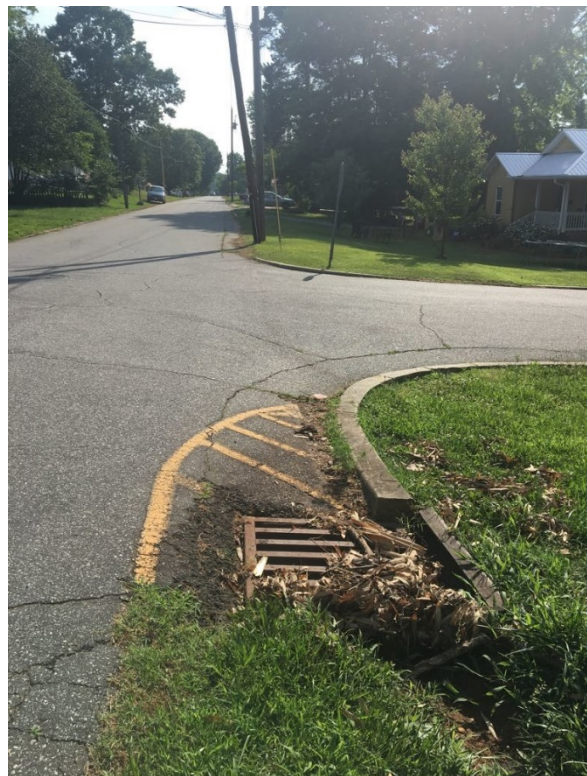
Structure ID: G4TN_CB02

Observed condition: Needs Improvement

Condition description: Curb metal piece has fallen off of curb, 2 grate pieces do not appear secure.
Asphalt crumbling around grate

Cleanout description: Bamboo, large branches, and a shoe blocking all inflow

Pollutant description: litter

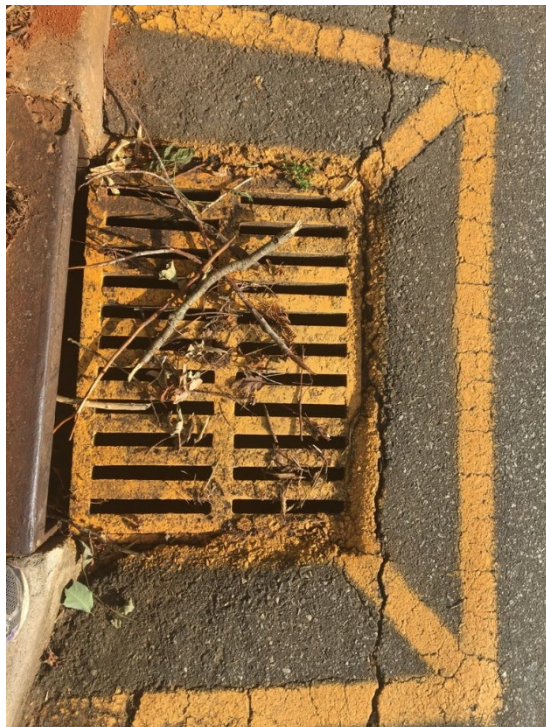
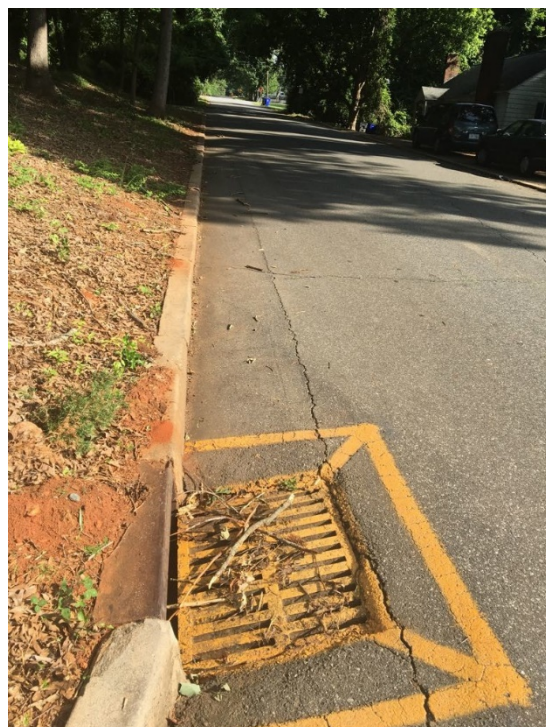
Structure ID: G4TN_CB03

Observed condition: Needs Improvement

Condition description: Black corrugated inflow pipe at an angle, possible unsecure

Cleanout description: Branches, litter

Other comments: Cleaned by Siler City staff 5/2020

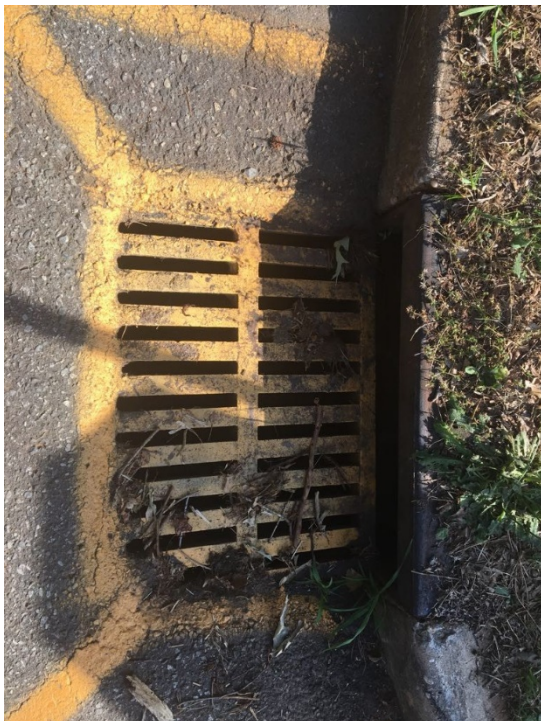
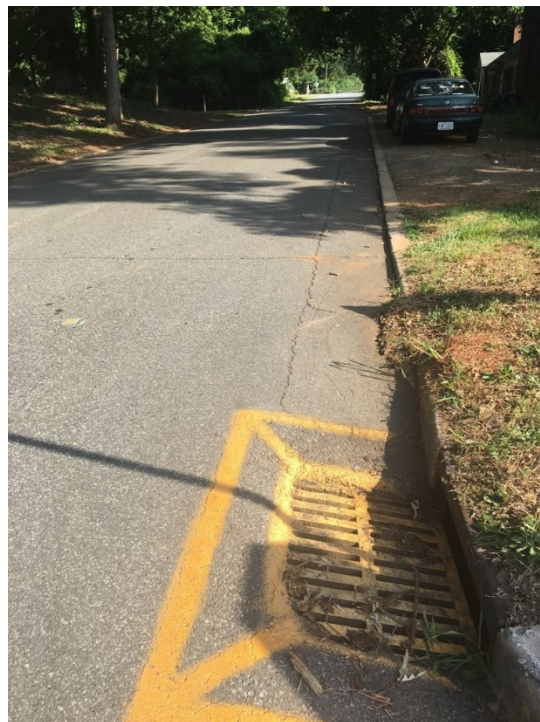
Structure ID: G4TN_CB04

Observed condition: Needs Improvement

Cleanout description: Grate currently clear, a lot of woody leaf matter in bottom of catch basin

Other comments: Cleaned by Siler City staff 5/2020

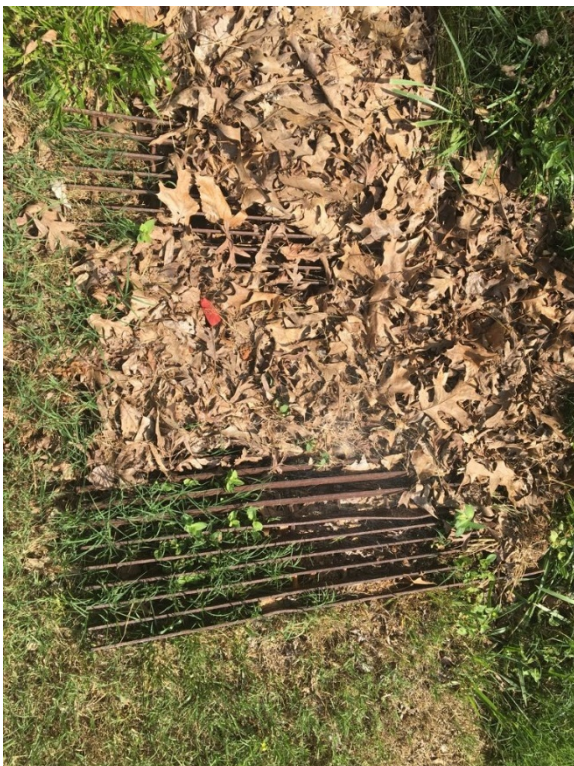
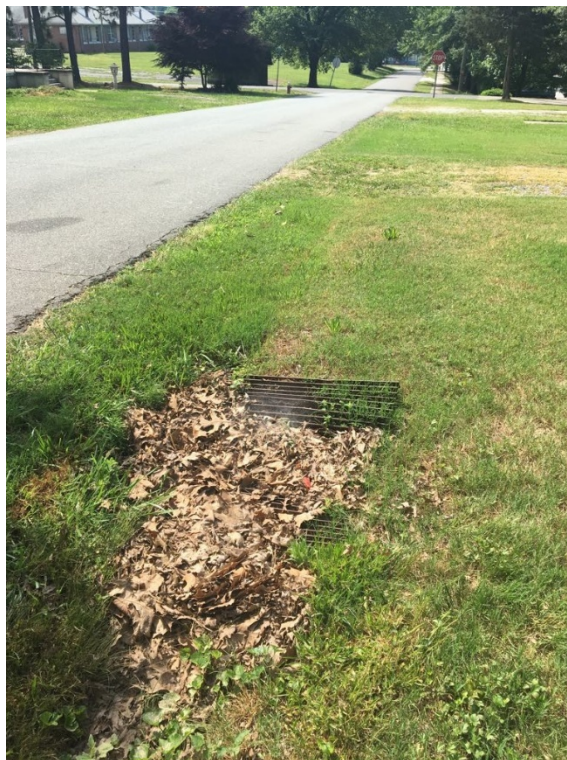
Structure ID: G5TN_CB01

Observed condition: Needs Improvement

Condition description: Grate appears collapsed

Cleanout description: Covered in leaves and debris

Other comments: Cleaned by Siler City Staff 5/2020

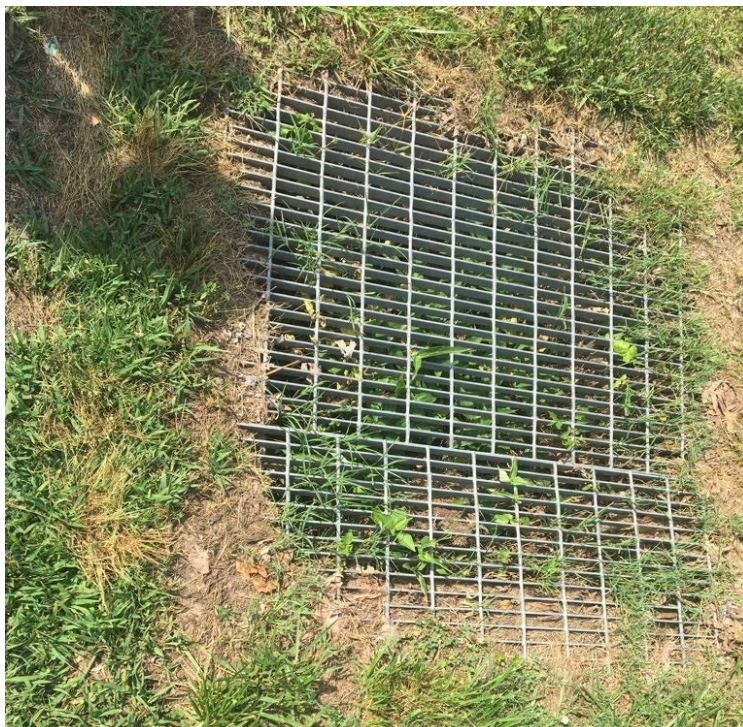
Structure ID: G5TN_CB02

Observed condition: Needs Improvement

Cleanout description: Vegetation growing inside grate

Pollutant description: sediment

Other comments: Cleaned by Siler City Staff 5/2020

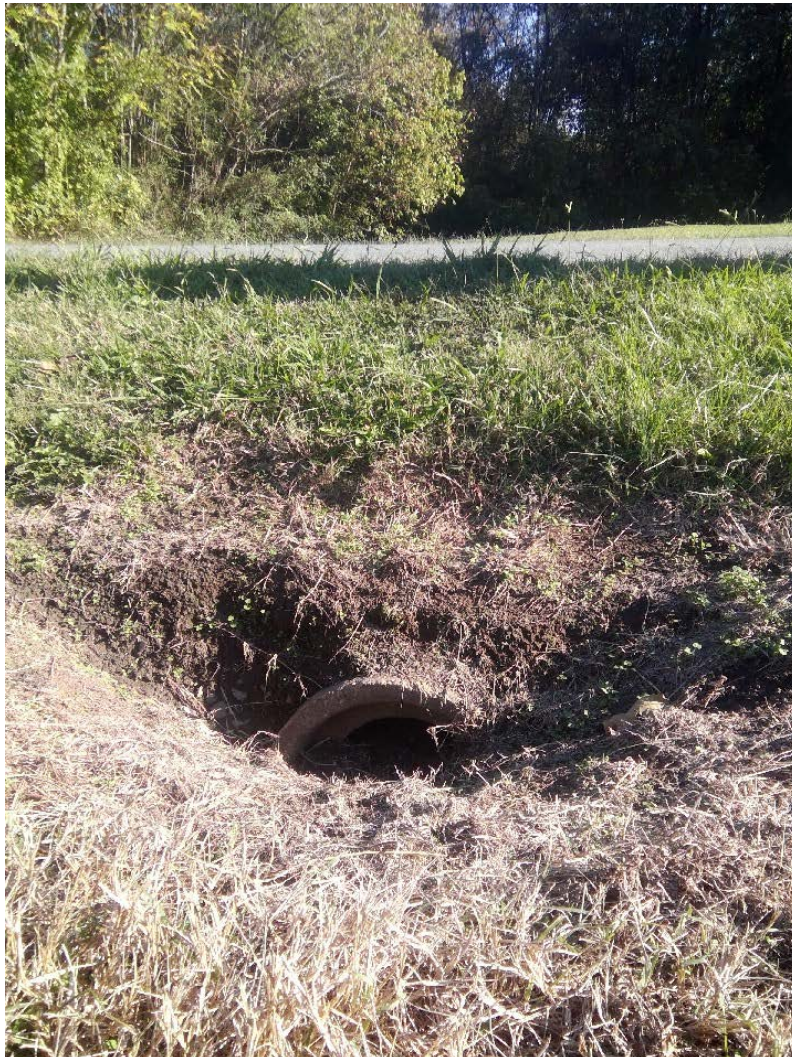
Structure ID: G6TN_CV01

Observed condition: Needs Improvement

Cleanout description: More than half buried, can't find outflow, on private property, where sinkholes are forming

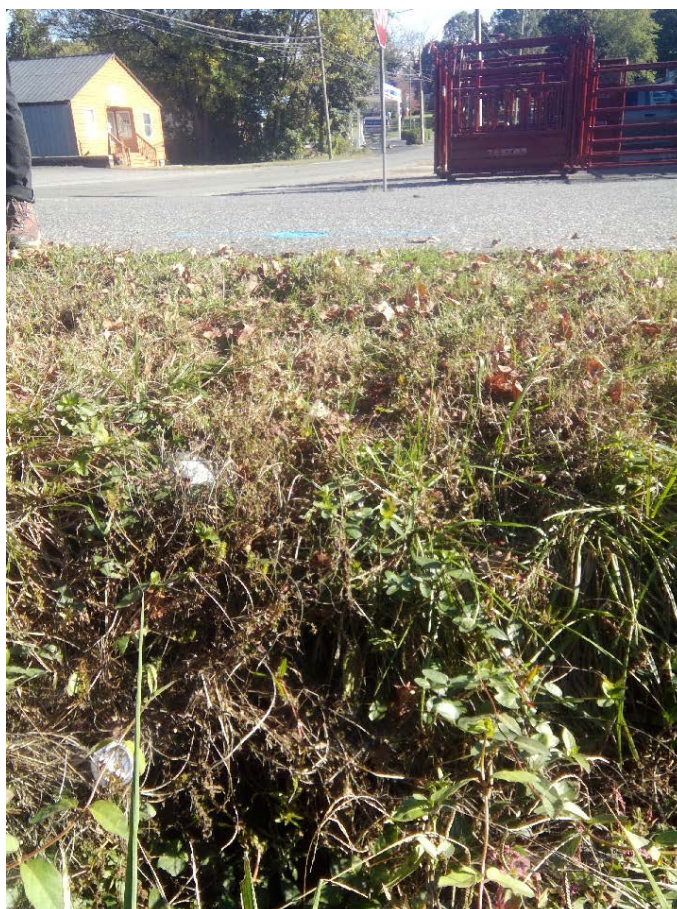
Structure ID: G6TN_PI01

Observed condition: Needs Improvement

Condition description: Pipe partly broken, ditch inflow full of veg/trash

Cleanout description: Ditch inflow full of veg/trash

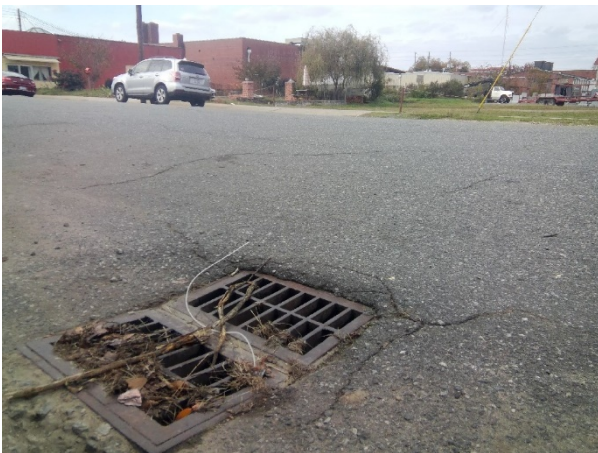
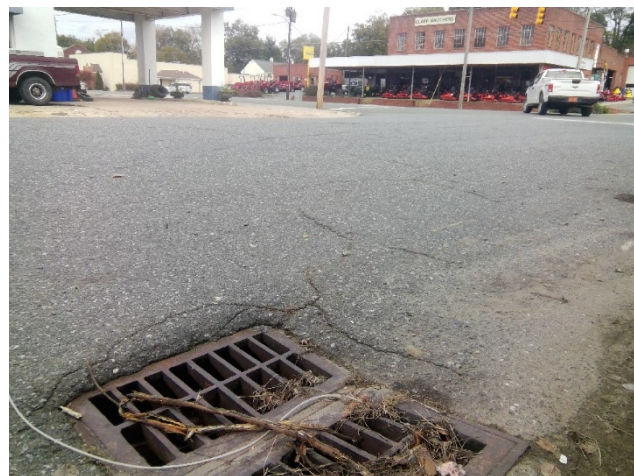
Structure ID: G7TN_CB04

Observed condition: Needs Improvement

Condition description: Inlet pipe half buried, standing water in basin

Pollutant description: Litter and woody debris

Other comments: Business owner reports regular flooding during average rainstorm

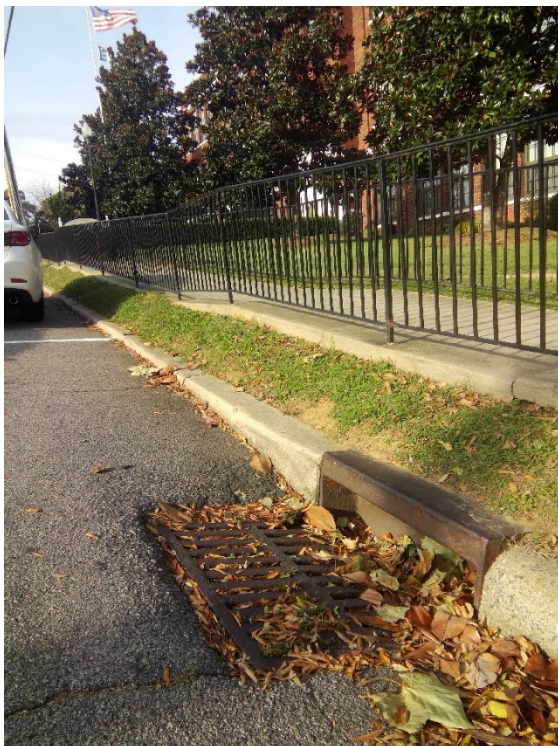
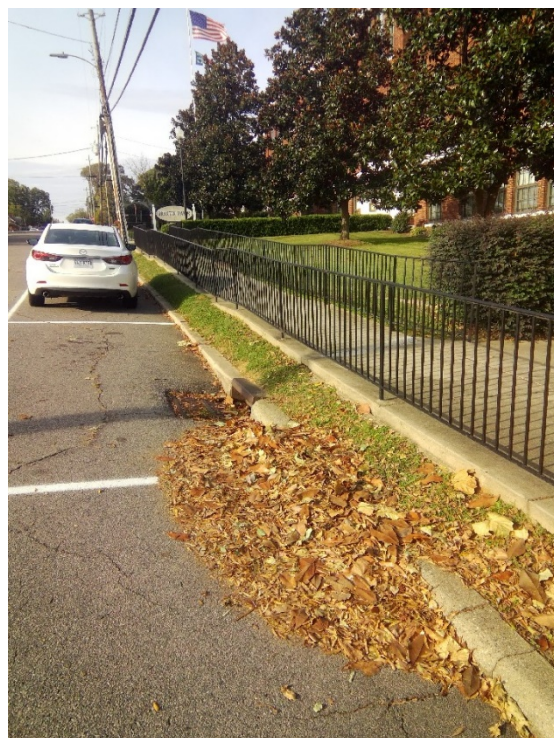
Structure ID: G8TN_CB01

Observed condition: Needs Improvement

Condition description: Completely full of leaves, can't see in at all

Cleanout description: Full of leaves

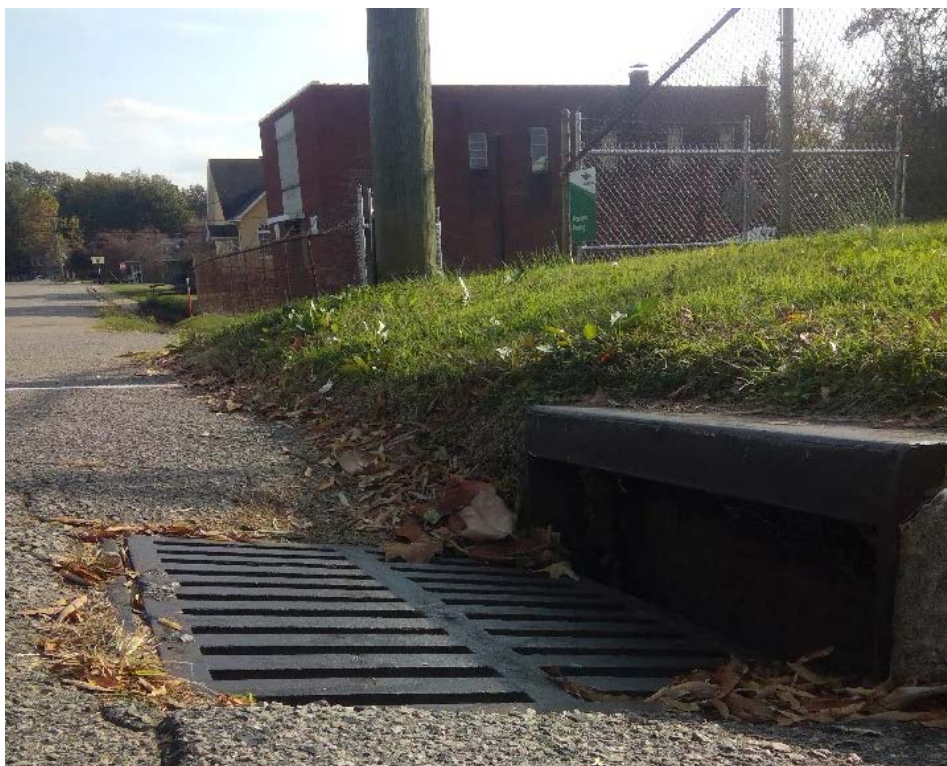
Structure ID: G8TN_CB02

Observed condition: Needs Improvement

Condition description: Grate cracked

Cleanout description: Full of leaf litter

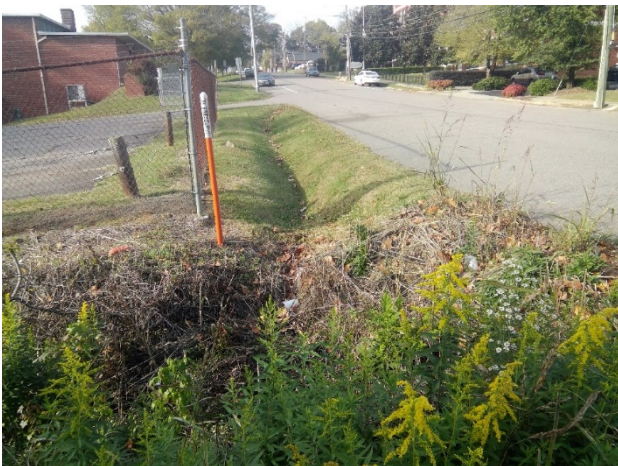
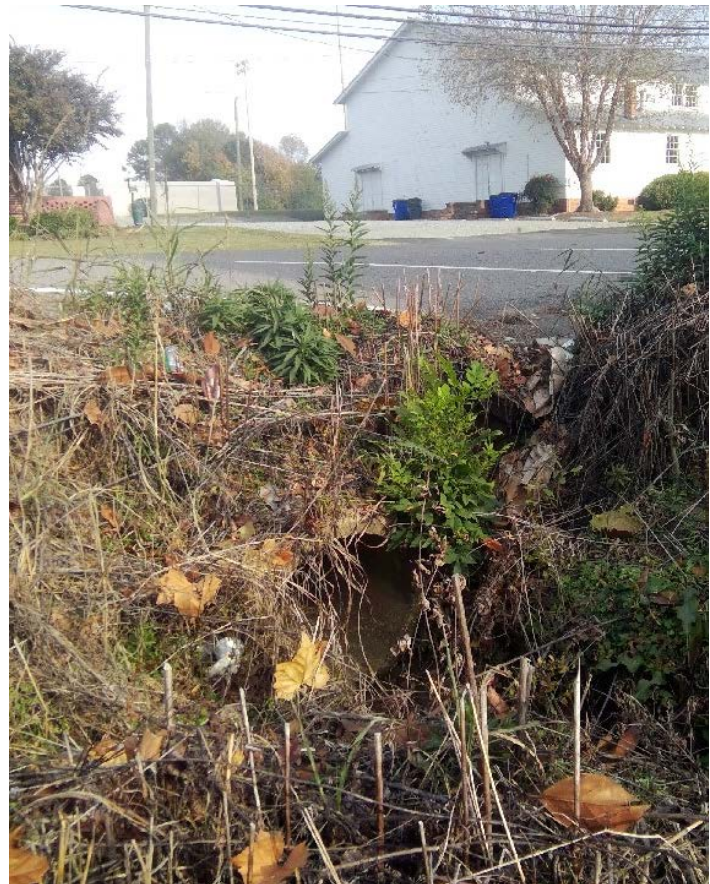
Structure ID: G8TN_OF01

Observed condition: Needs Improvement

Condition description: Pipe outfalls to ditch on private property by masonic temple. Lots of litter.

Pollutant description: litter

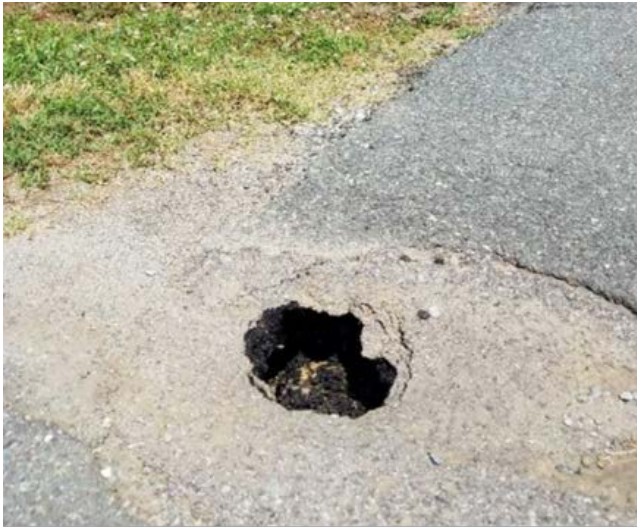
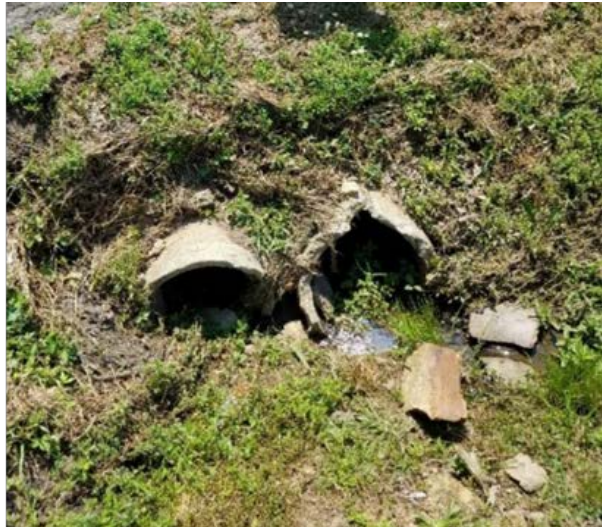
Structure ID: H5TN_CV01

Observed condition: Needs Improvement

Comments: 2 pipes. Broken concrete lip of both pipes. Sinkhole right over pipe! Neighbors said sinkholes recently covered with gravel and asphalt, and now it's open again.

Cleanout description: Partly buried, broken concrete and vegetation, standing water. Active sinkhole(s) forming over pipes.
