Siler City Stormwater Infrastructure Lookbook: Town-Owned Streets

Highest-Priority Stormwater Infrastructure Maintenance Needs
Version date: June 2020

Completed as Part of the Siler City Stormwater Mapping and Assessment Project

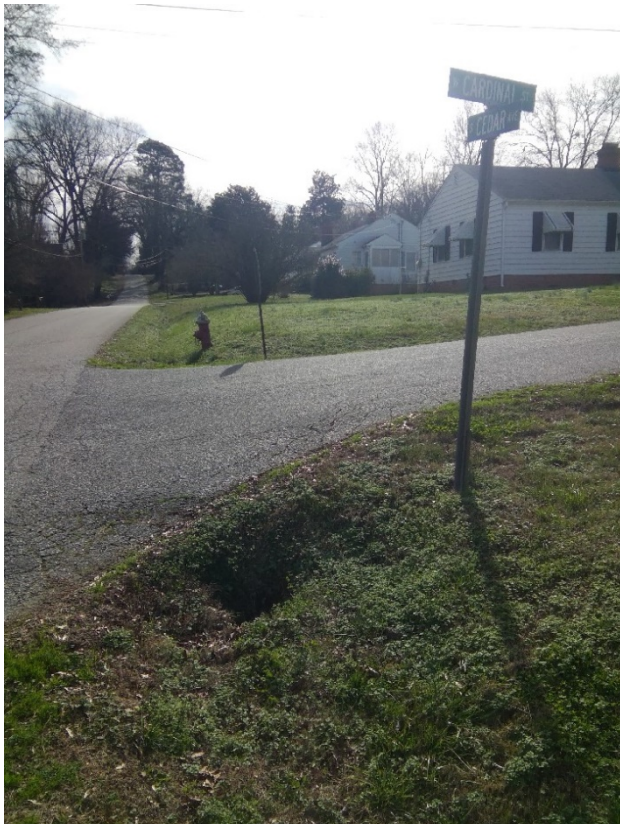
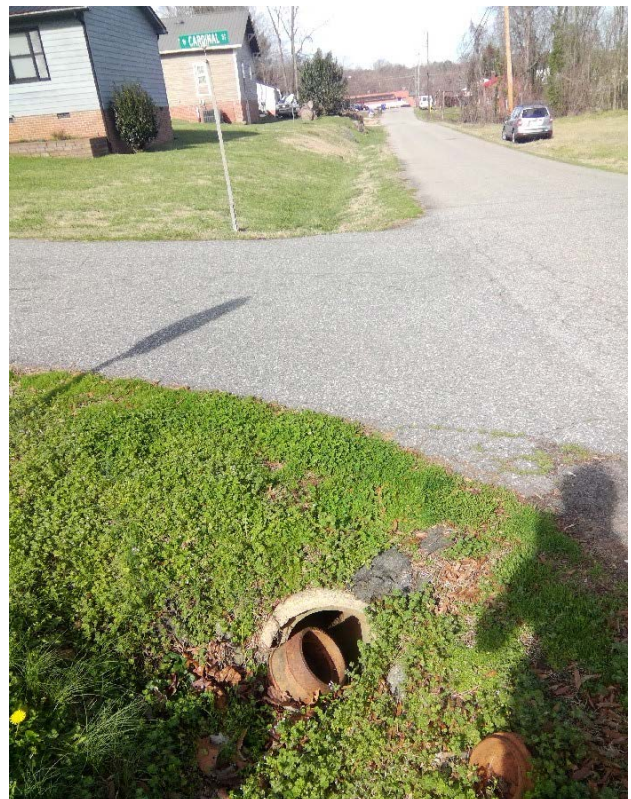
Structure ID: H6TN_CV01

Observed condition: Needs Improvement

Cleanout description: Downslope end buried

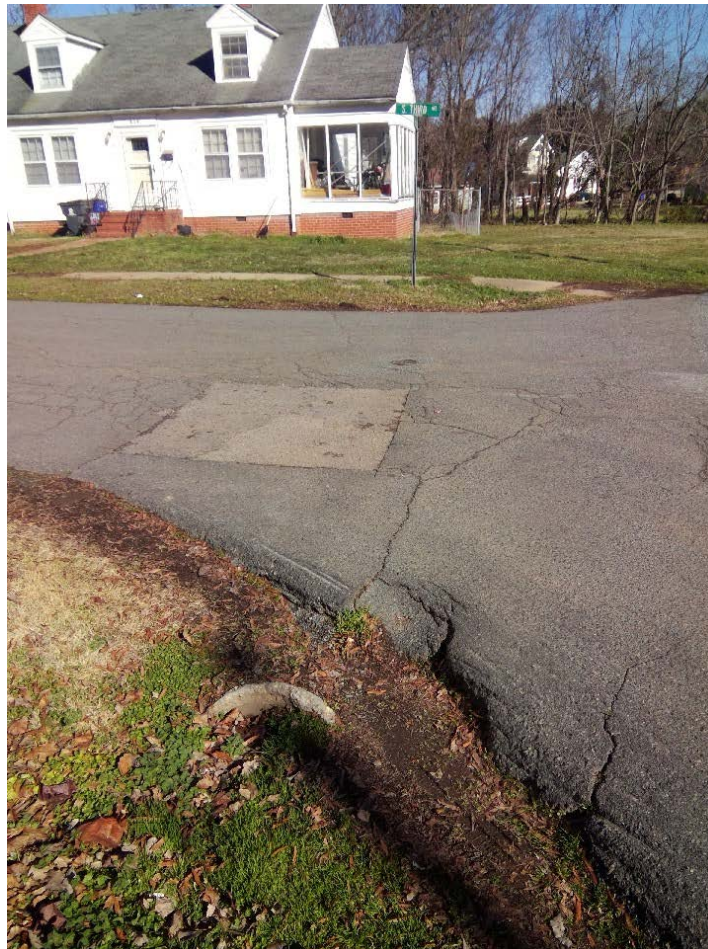
Structure ID: H9TN_CV01

Observed condition: Needs Improvement

Cleanout description: Completely buried

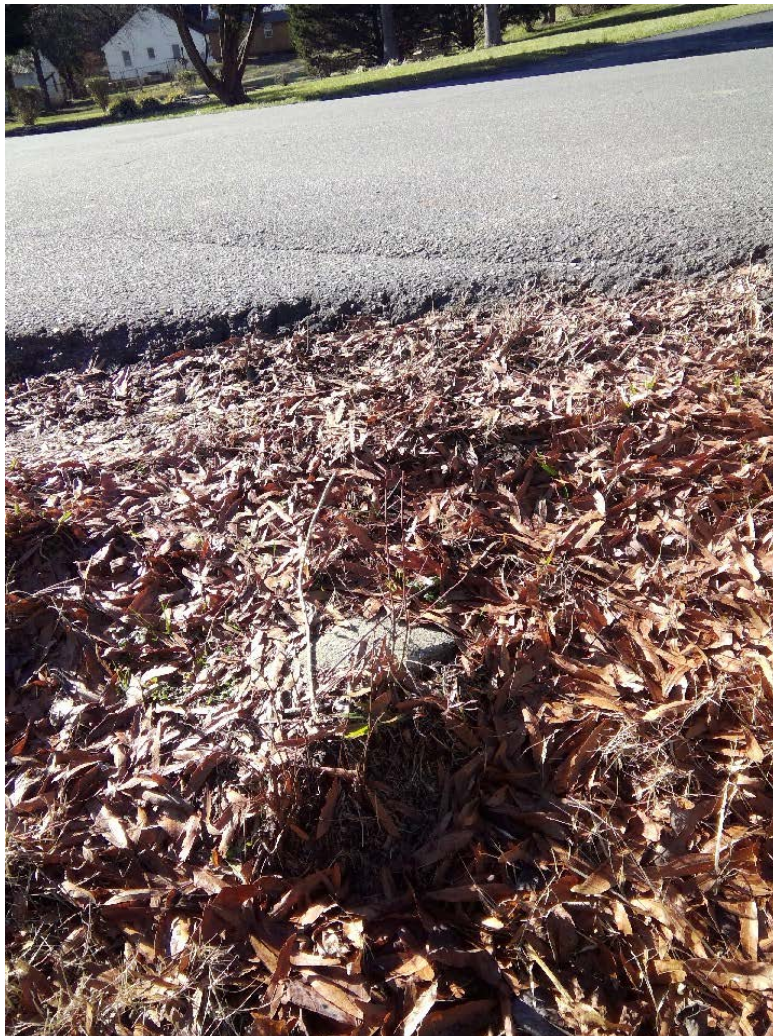
Structure ID: H9TN_CV04

Observed condition: Needs Improvement

Cleanout description: Fully buried on upslope end

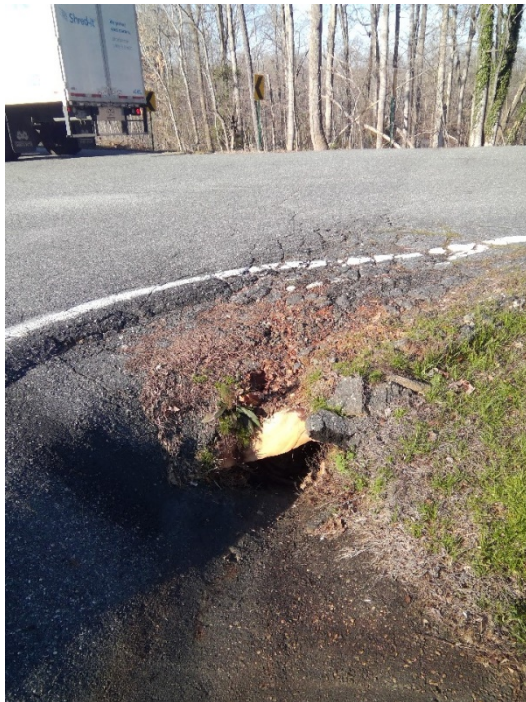
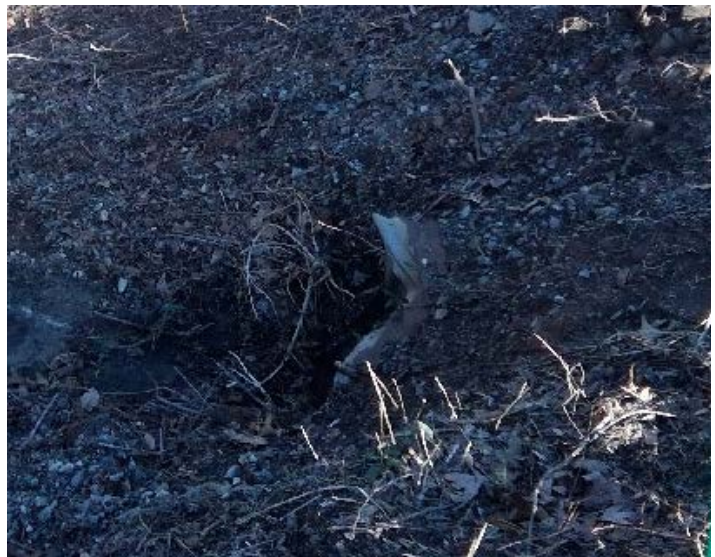
Structure ID: I4TN_CV01

Observed condition: Needs Improvement

Comments: Partly crushed metal pipe

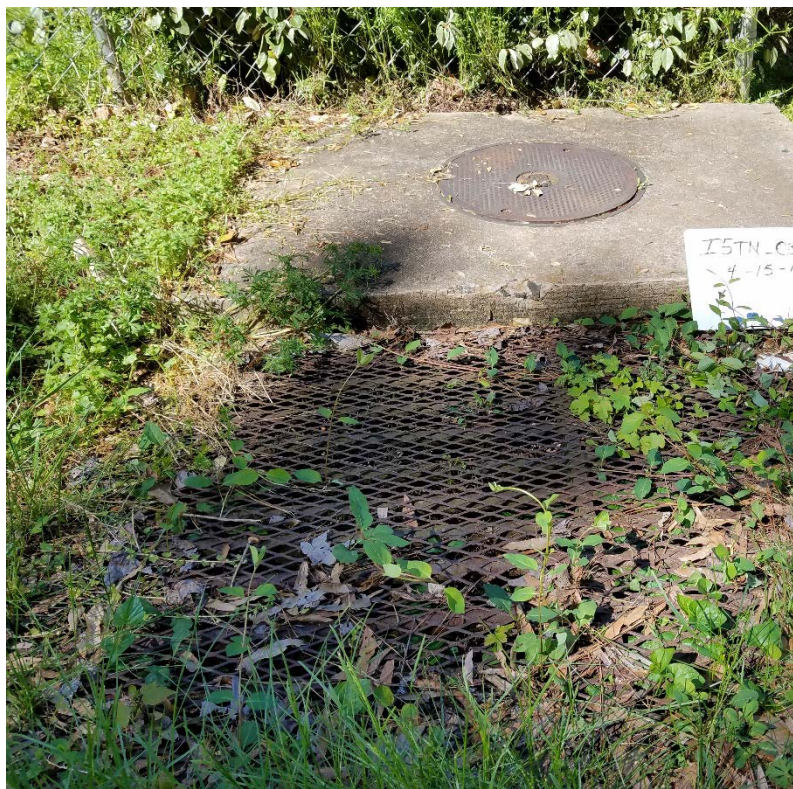
Structure ID: I5TN_CB02

Observed condition: Needs Improvement

Condition description: lots of plants growing up through

Cleanout description: Can't see structure, small trees/vines growing up through grate, overgrown

Other comments: Can't see number of pipes

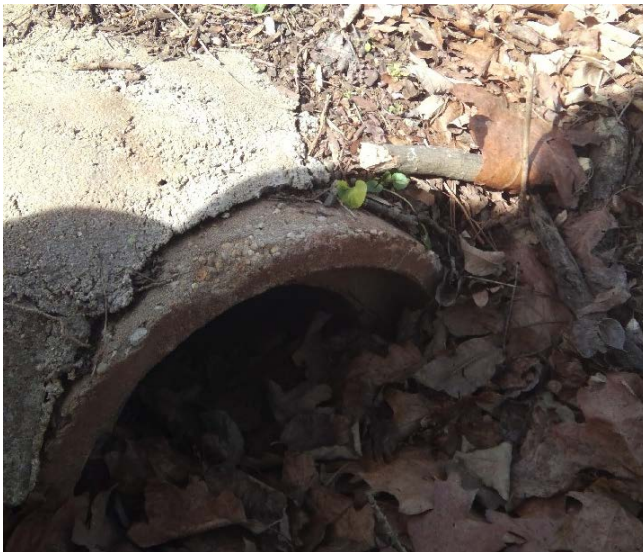
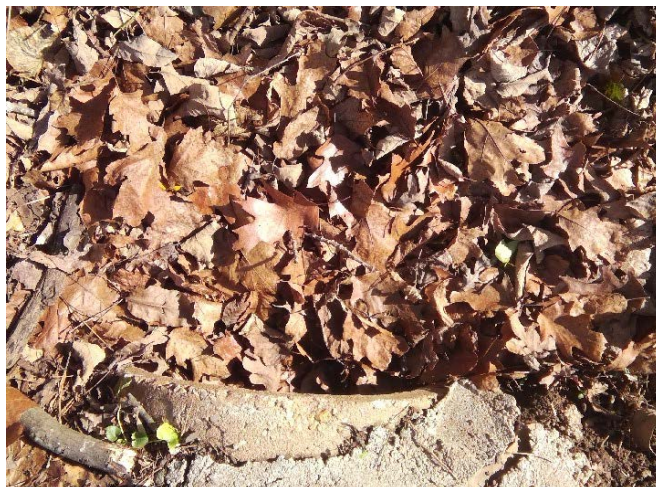
Structure ID: I5TN_CV04

Observed condition: Needs Improvement

Cleanout description: Buried culvert connects to CB. Crack in road over culvert.

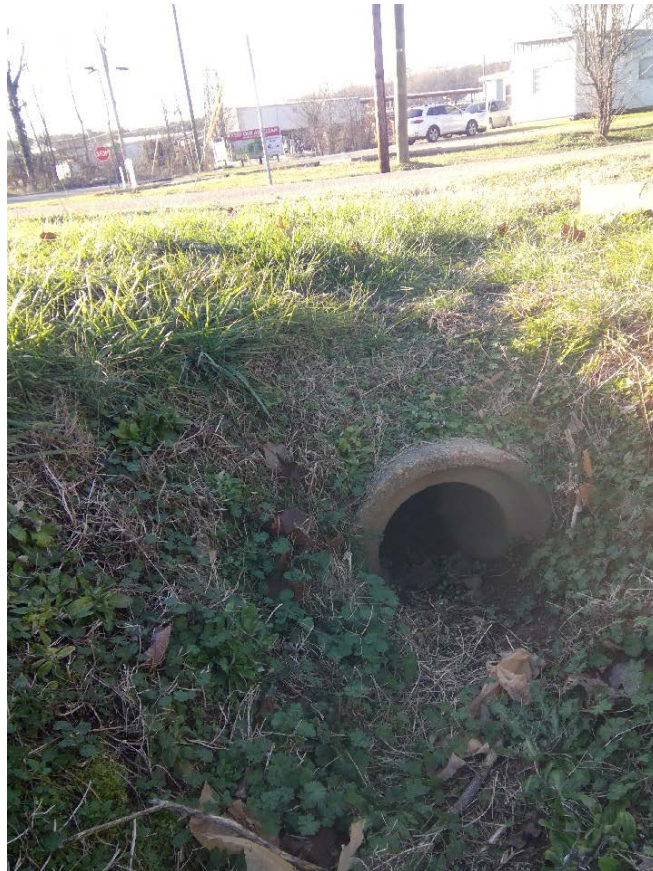
Structure ID: K9TN_CV01

Observed condition: Needs Improvement

Cleanout description: Downslope end buried
