Final Report

Siler City Stormwater Infrastructure Mapping and Assessment Project

June 2020

Prepared by the
Triangle J Council of Governments
in partnership with
Biocenosis, LLC

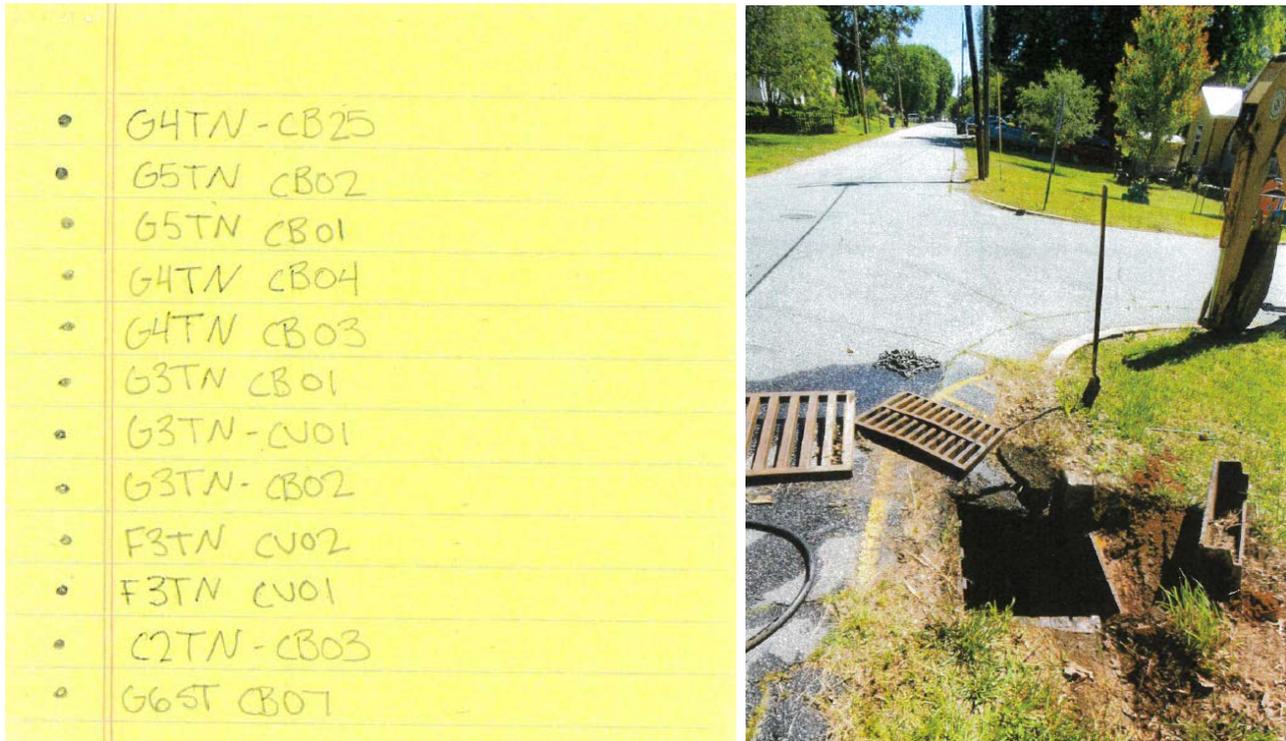
Figure 9: Stormwater Infrastructure Cleaned Out May 2020

Based on preliminary results that TJCOG and Biocenosis shared with Siler City staff at a May meeting, Siler City staff cleaned out the following infrastructure features:

The infrastructure cleaned out in May 2020 has been noted in all map formats while remaining in the “cleanout needed” field due to likelihood of these infrastructure features filling up again as they drain low-lying areas which receive large volumes of debris in stormwater runoff.

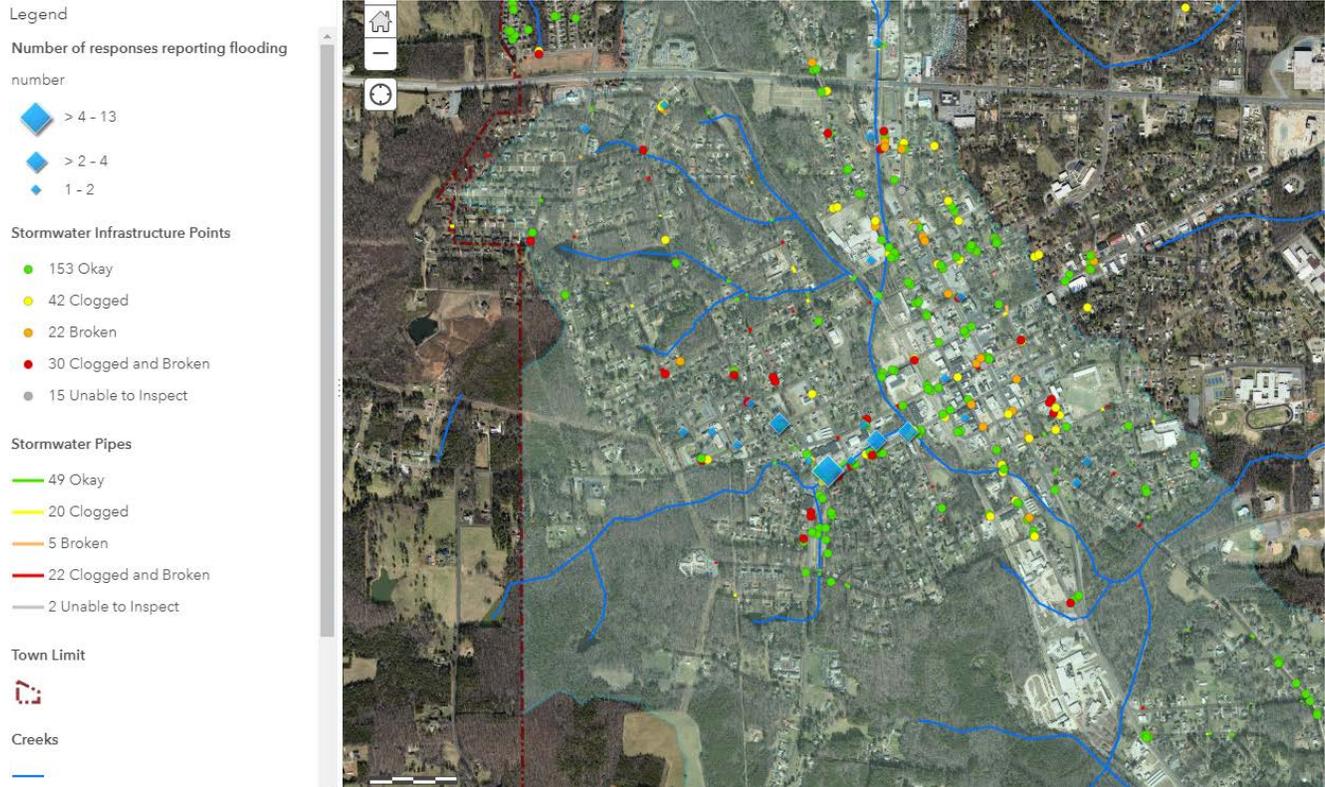
6.3 Appendix III: Flooding Locations Identified by Public Input Survey and Field Assessment

- The field data and public input showed that there was more flooding in areas with clogged or otherwise non-functioning stormwater infrastructure (see map in Appendix 4.)
- Some stormwater infrastructure at low elevation points was clear, as Town staff has cleaned out some of the “problem” spots based on citizen complaints.
 - A list of infrastructures cleaned out between February 2020, when data collection concluded for this project, and May 2020, when this report was written, was provided by Public Works staff and noted in the webmap/ Figure 8.
 - After June 2020, Siler City Public Works staff stated their intention to keep a running list of stormwater infrastructure that they clean out to keep stormwater infrastructure condition data current.
 - Project data will be readily updateable on Chatham County’s Open GIS Data page.

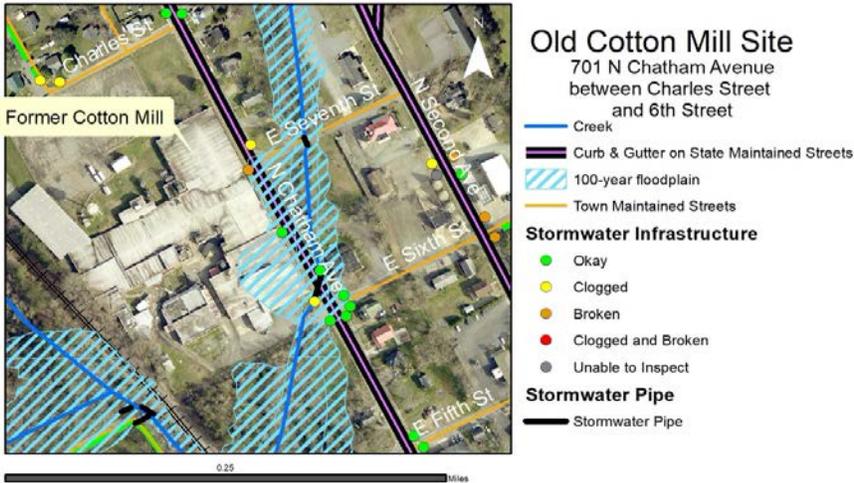
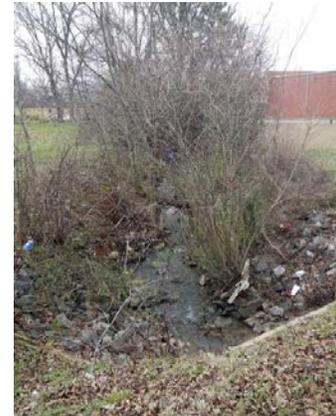
Former Cotton Mill Site (Grid E6)

The area around a former cotton mill located on N. Chatham Avenue has for decades seen frequent flooding and erosion issues. The mill is located partially within the 100-year floodplain and just upstream of the confluence of Tributary 1 of Loves Creek with a headwater stream. Some surrounding properties have open space that could potentially be used to implement stormwater control measures (SCM) to capture and slow stormwater runoff from the mill site before it enters the creeks.

Creek after it flows under 7th St. prior to flowing past the old cotton mill.

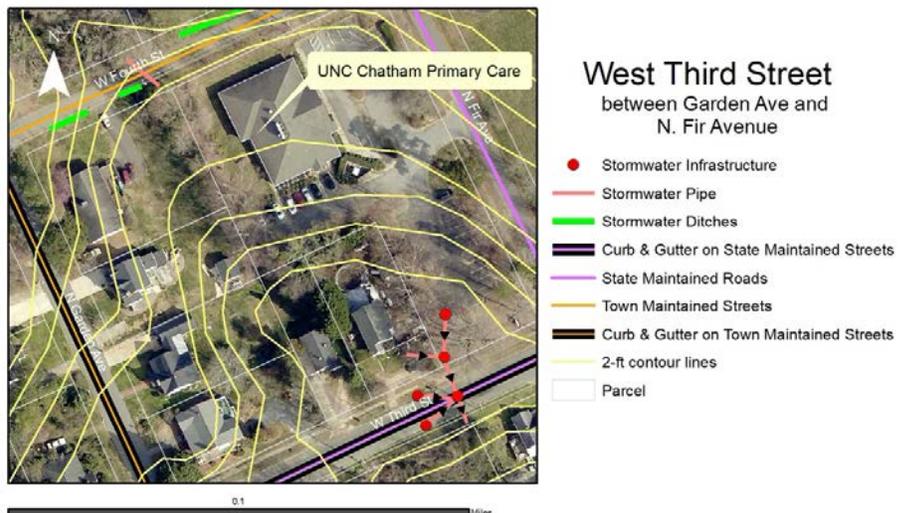
Stormwater runoff on W. Third Street

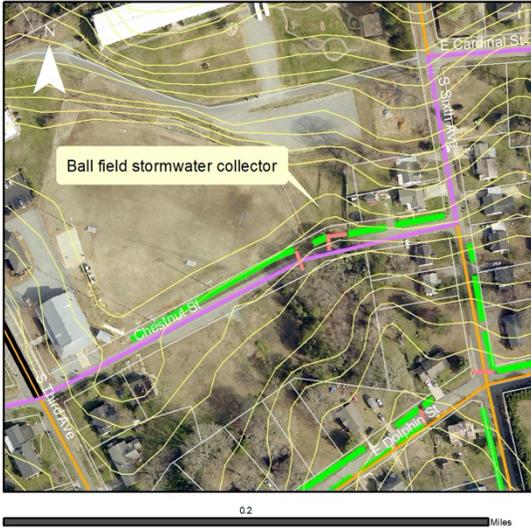
Paul Braxton Gym Ball Field Stormwater Collector (Grid G9)

A stormwater collection system east of the Paul Braxton Ball Field on Town property directs stormwater to the stormwater pipe that flows under Chestnut Street. The outflow system is broken and eroding. Potentially a SCM such as a Regenerative Stormwater Conveyance system could be installed to slow and reduce the flow.

Ball field Stormwater
